# SOME IMPROVEMENTS IN THE DESIGN AND OPERATION OF COAL FIRED BOILERS

By JOHN X. SHUM

*Hulett's South African Refineries Limited*

This paper deals with five problems experienced in the operation of coal fired boilers and the methods by which these problems were overcome. The paper is divided into five sections, each dealing with a specific problem, although some of the problems are inter-related. Drawings are diagrammatic but charts shown are from the boiler instruments.

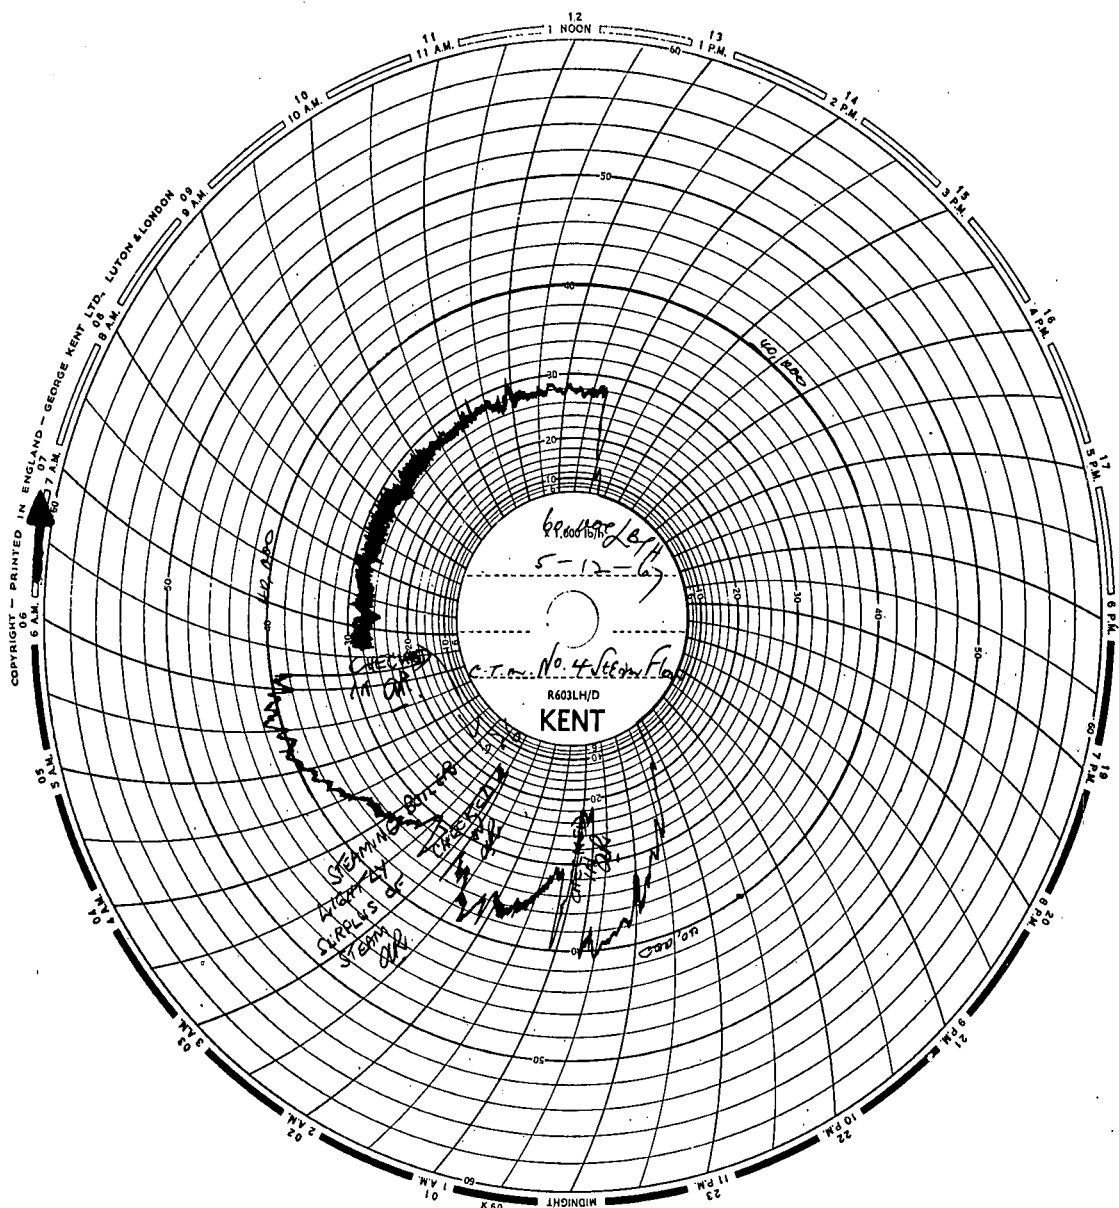
CHART 5

As can be seen from Chart No. 5 the boiler gave its maximum steam output again after cleaning.

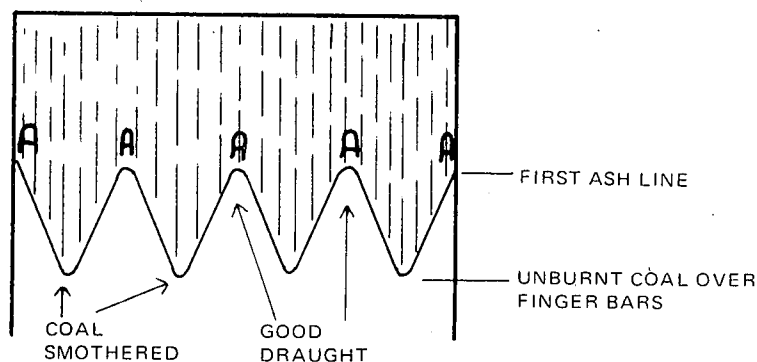
DIAGRAM NO. 3: Plan of grate showing fingers of unburnt coal.

Dealing with the effect of coal separation on combustion, it will be seen from diagram No. 3 that initially ignition was good, but as the grate moved forward the combustion was better through the larger particles and consequently this coal had burnt out to ash at section marked first ash. The draught now had an opportunity of rushing up through this ash and failed to penetrate the portion where the fines were located, consequently this section was starved of air and failed to burn, with the result that it passed over the finger bars unburnt and gave the high percentages of combustibles in the ash of 27% and even higher.

The heat passing over the mass of fines tended to fuse the surface and prevent the portion beneath from reaching combustion temperature and burning. A most uneconomical method of fuel consumption.

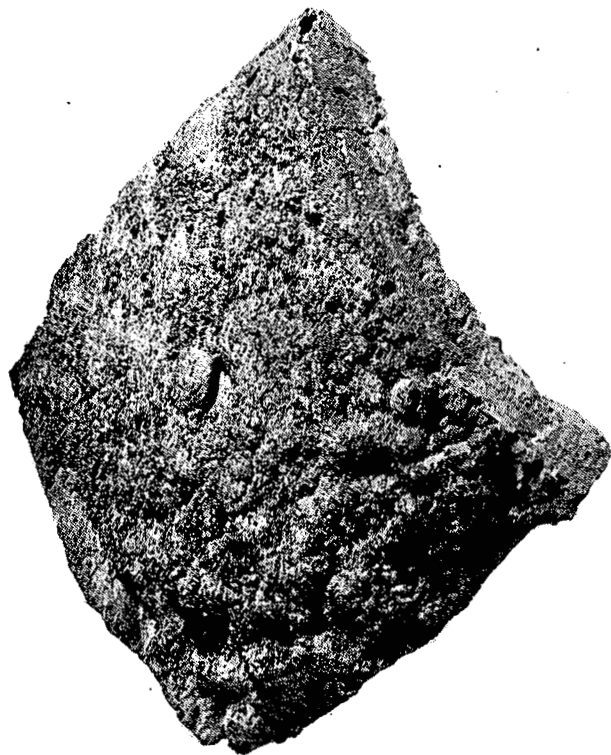
tive effect until ultimately all tube passages were choked. See photograph "A".

A: Deposit taken from generating tube showing heavy build-up causing chokeage through birdnesting. Chord dimension 4".

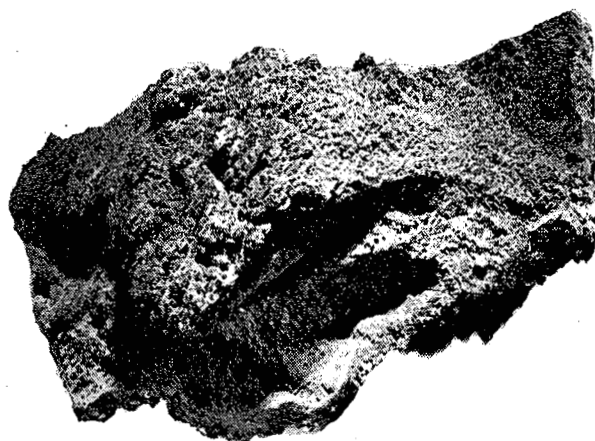
Initially the clinker formed was of comparatively small size, about 4 inches square and about half-an-inch to 1 inch thick. This clinker could be handled by the ash hopper and the paddle ash units. The clinker-forming property of the coal gradually deteriorated until eventually it was coming up to the finger bars at the end of the grate in a plastic state and instead of rising over the finger bars it was pushing them away from the grate. In a number of instances it broke the bottom lugs of the finger bars which then fell into the ash hopper and had to be removed from the side clearing door. Looking through the side inspection door of the boiler between the water tubes the clinker could be observed as it travelled along on the chain grate, lodged against the finger bars and gradually buckled upwards, holding back clinker behind it. Some of the clinker would buckle upwards until vertical and then slowly bend backwards into the boiler like a stick of soft toffee on a hot day.

C. Clinker sample clearly showing the folds which formed at the finger bars while still in its plastic state. Sample 6" long.

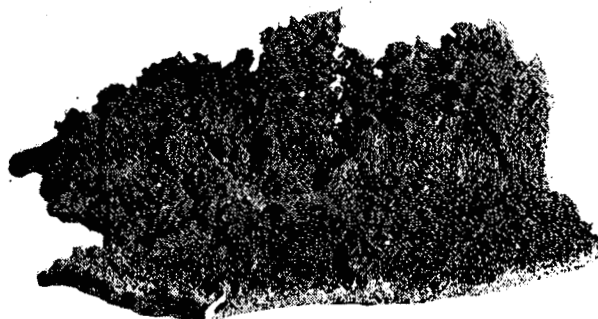
D. Sample taken from 2nd tube on side water wall adjacent to ignition arch showing friable surface next to the tube and dense mass at rear of mass (fireside). Sample about 8" long.

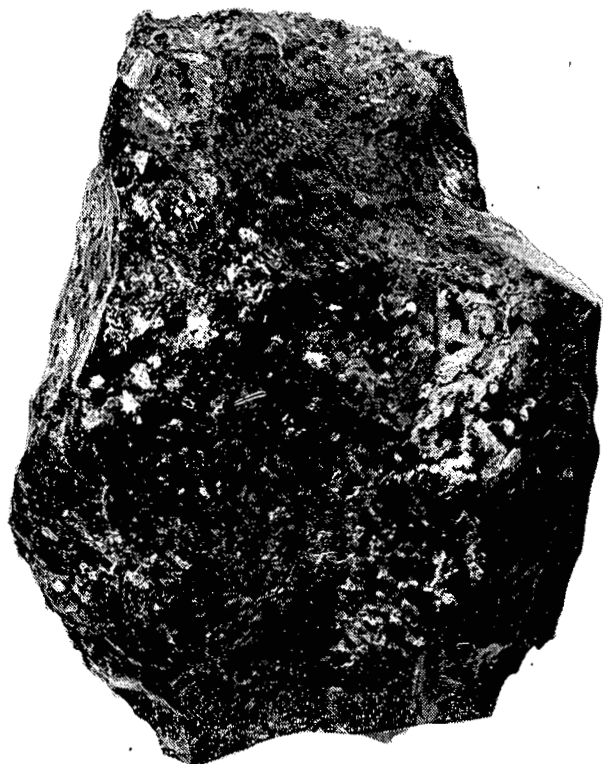
B. Vitrified deposit taken from boiler arch brickwork. 3" maximum horizontal dimension (thickness).

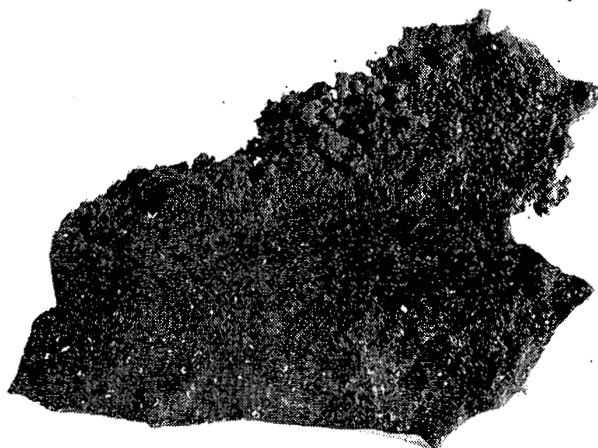
E. Reverse view of photograph D showing dense mass of clinker attached to the tube as seen from the fireside.

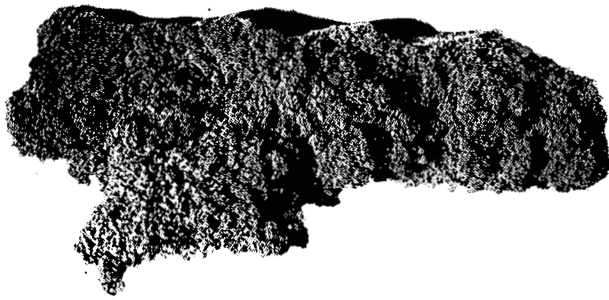
The composition of the coal ash differs considerably from that of the deposit. With the high iron and calcium content of both, a fairly low ash fusion temperature is to be expected.  
(The deposit on the tubes is shown in photograph "G")

G. Sample from boiler being treated. The soft friable nature of the deposit can be clearly seen. Sample  $7\frac{1}{2}$ " long.

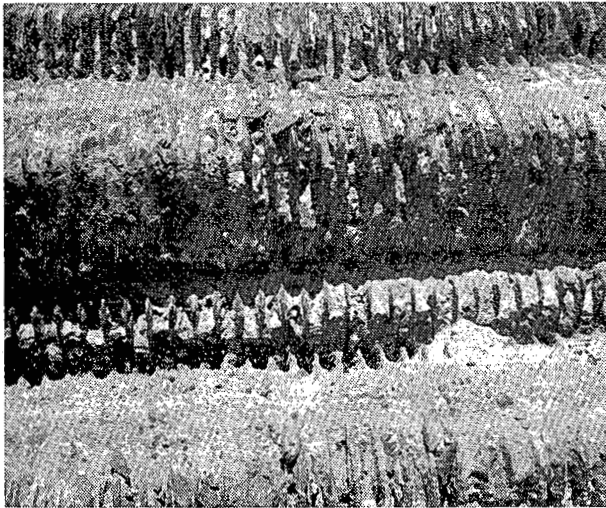
miser tubes in a clean condition. The normal routine was to sootblow them once per shift and water-wash every second day. Photograph H indicates the condition of the tubes removed from the economiser at the end of a year's steaming under the above conditions.

Photograph H shows the condition of the finned tubes when they had to be removed for thorough cleaning. As can be seen these tubes are choked to such an extent that the boiler could only steam with the by pass flues partly open — a severe waste of heat.

H. Economiser tubes choked with deposit. All tubes had to be removed from economiser and each one physically cleaned to bare metal. Boilers sootblown daily, economiser waterwashed every second day. Before flyash arresters fitted.

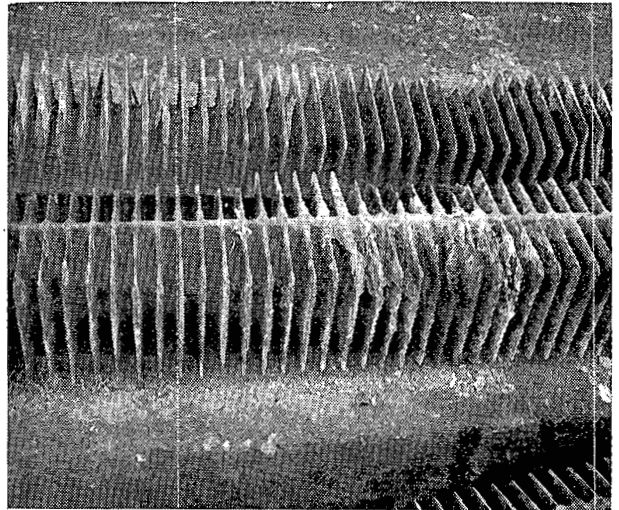
Photograph J shows the tubes after 12 months' steaming with flyash arresters fitted and without using water washing. Incidentally, the part of the tube showing partial choking is where there had been a leakage from above this area. This would appear to support the instructions regarding the abolition of water washing.

I. Economiser tube after 12 months' steaming with flyash arresters fitted. Normal sootblowing. No waterwashing. Note the effect of water on the tubes where slight build-up has occurred.

Water washing an economiser causes corrosion of the tubes and fins and this irregular surface permits dust and fly ash to adhere and cause a build-up and consequent choking of the tubes as can be seen—photograph 1. Our experience has been that, without water washing, the tubes have remained clean and the gas flow remains unimpeded.
