# THE DESIGN AND INSTALLATION OF BFP CHAIN

By W. J. WEBB

C. G. Smith Sugar Ltd, Sezela

### Abstract

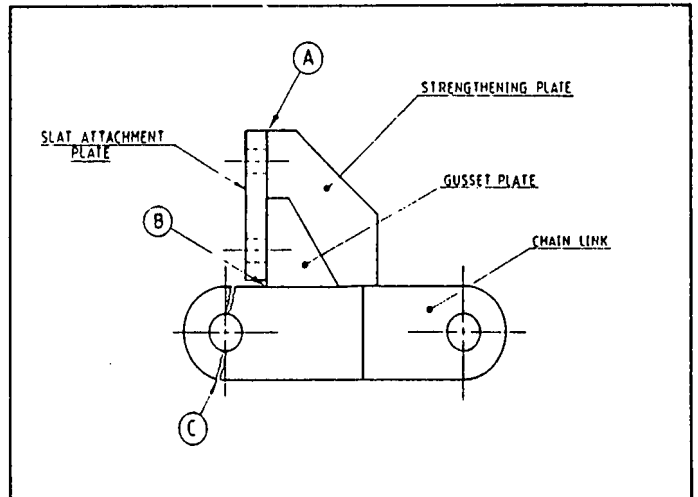
FIGURE 1

1. The carriers were fitted with BOP cranked link type chain (see Figure 1) in 1983.
2. Soon after start up numerous slat attachment plates broke off from the gusset plate along line A as shown in Figure 1.

3. The weld between the slat attachment plate and the gusset plate was then improved because, on examination, it was clear that there was a lack of weld penetration between this plate and the gusset plate.

4. Numerous gusset plates then broke off from the chain link along line B as shown in Figure 1.
5. The links were then examined carefully and the heat treatment checked. As the heat treatment was found to be in order and no corrosion fatigue could be found, it was decided that the links had broken because they were under designed. The links were then reinforced with a strengthening plate as shown in Figure 1.

8. The chain then broke at the interface of the bush and side bar (point C in Figure 1) causing a 36 hour stoppage. Again the links were examined carefully and the heat treatment checked, and again it was felt that the breakage was due to under design.

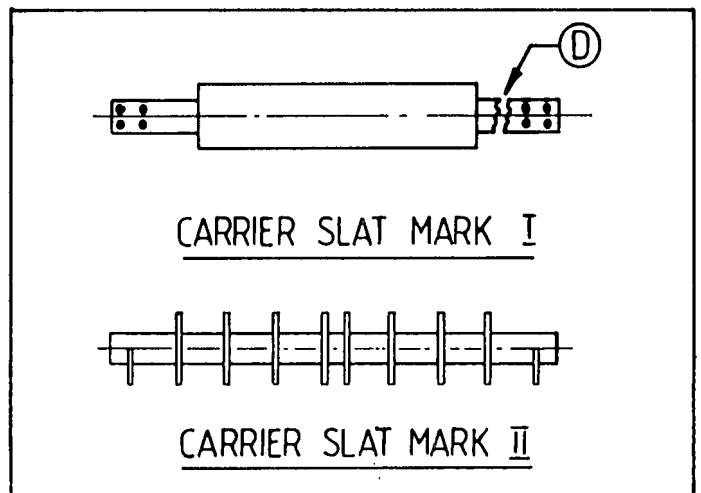
FIGURE 2

6. The slats then broke at point D as shown in Figure 2 on the Mark I slat.
7. A modified slat was then installed, which consisted mainly of two 100 x 60 unequal angle irons welded toe to toe (Mark II in Figure 2 refers).

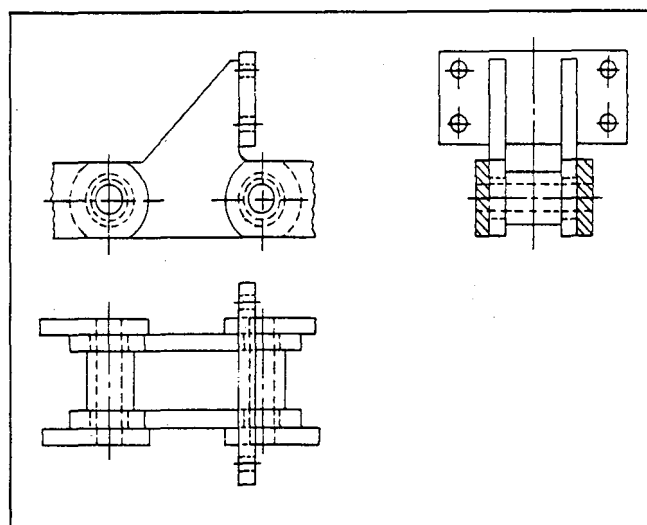
FIGURE 4

Two types of chain were considered, one with the existing Sezela attachment and the other with a side lug attachment. The No. 3 carriers were fitted with the Sezela attachment and the other carriers were fitted with the side lug type chain. Refer to Figures 3 and 4 for illustration of the attachment styles.

The reason for going over to the side lug type chain was to eliminate the bending moment, which was a contributing factor in the gusset breakage on the BOP type chain. Because none of the gussets broke on the BFP chain it was decided to run with the two types of chain, and when time and money became available to change over to the side lug type chain.
