PROBLEMS WITH CE VU20 BOILER AT GLENDALE

F FOKKENS

Glendale Sugar Millers (Pty) Ltd

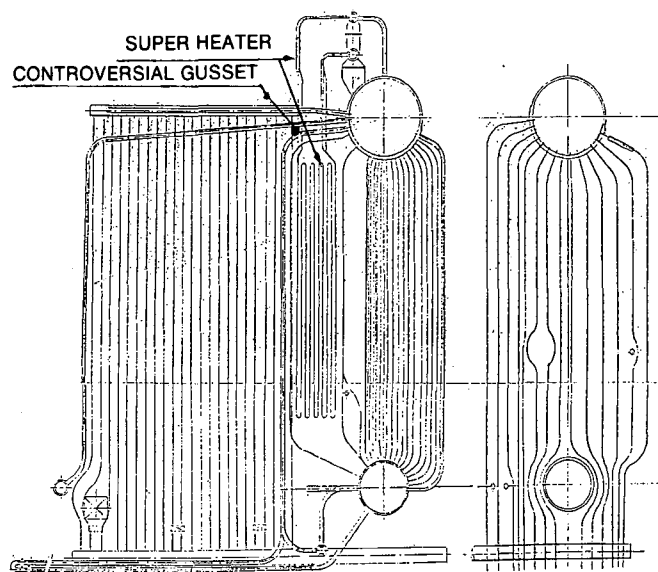
FIGURE 1 Layout of the boiler.

The feedwater temperature and flow were checked, nothing being out of standard. The pH was brought down from the 11,7–12 range to between 10,5 and 11,2 to prevent possible priming. The total dissolved solids (TDS) was extremely low at 300–500 ppm. Eventually a long weekend stop was scheduled for an internal inspection. Nothing appeared to be wrong, but upon pressure testing a series of weeping leaks was found on the gusset position between the roof and rear wall tubes (Figure 1). Why the gussets were fitted during the 1992/93 offcrop is outside the scope of this paper. The problem of cracks around the welds, next to the superheater tubes was assumed to have been the reason of the temperature drops. The gussets were removed, the cracks repaired, the boiler steamed up and the same problems occurred again, just as before!

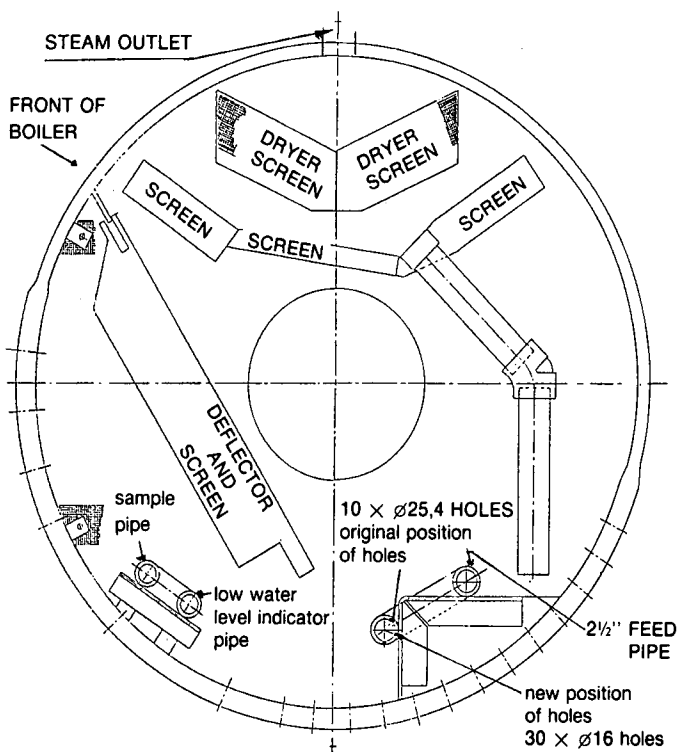
FIGURE 2 Details of the steam drums.

- Dirty superheater: unlikely because very dirty superheater tubes would overheat, and result in a bunch of spaghetti.
- Blocked steam separating screen: unlikely as it would cause a serious pressure drop.
- Mechanical problem in the drum with screens/feedwater pipe (Figure 2): unlikely as no water level problem was apparent.
- Contaminated boiler water *i.e.* presence of oil, hence causing foaming/priming: no traces of oil were found.

- The superheater tubes had a slight deposit, not of any significance but a residue was removed.
- The steam screens had more than a normal coating and had carbon residue from a slug of sugar on 25 August 1994. Far dirtier screens have in the past been removed at the end of crushing seasons.
- The feedwater pipe was fitted exactly according to the drawings. Two holes, however, impinged their water onto support brackets, which could possibly have created a fountain effect on the surface. This pipe has been there since 1978. A new pipe was fitted with many more, slightly smaller holes directed 10° down from the horizontal, not impinging on brackets.
- The bottom drum was completely clear of any loose deposit and only slightly scaled.

- clean the superheater chemically.
- clean all the screens.
- check and modify the feedwater pipe not to spray 10° up, but $\pm 10^\circ$ down.
- drain and refill the boiler with fresh soft feedwater.
