BOILER FLYASH AND EFFLUENT DISPOSAL AT UMZIMKULU

SSGGOVENDER

Umzimkulu Mill, Port Shepstone, South Africa

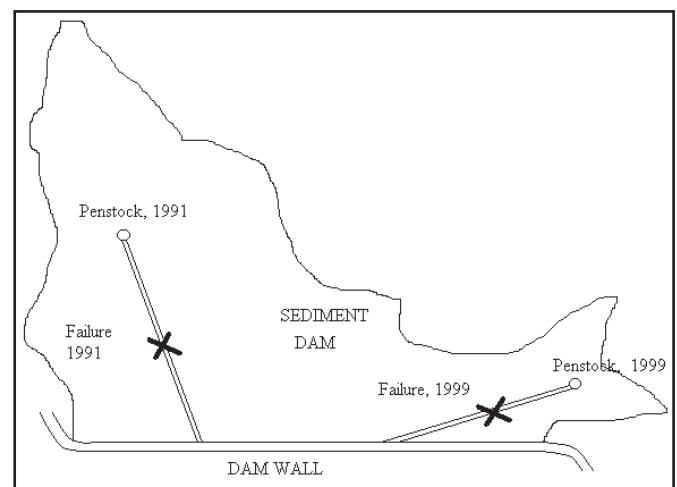
The concrete draw-off pipe from the penstock collapsed twice (1991 and 1999) resulting in uncontrolled release of sediment from the dam. Soon after the second failure an inspection of the draw-off pipe via a manhole revealed extreme corrosion of the concrete on the inner wall of the manhole. The corrosion was attributed to the presence of sulphuric acid found mainly in the sewage sludge but also to a limited extent in the coal ash. The Municipality sewage disposal into the dam was stopped immediately after the incident.

Another threat to the continued operation of the dam had to be contended with. In 1997 engineering geologists condemned further use of the dam. In their opinion it was not possible to evaluate the efficiency of the filter drainage system in the dam wall. They were concerned that the water table would rise within

FIGURE 1. Map of the sediment dam showing the locations of the spine drain failures.

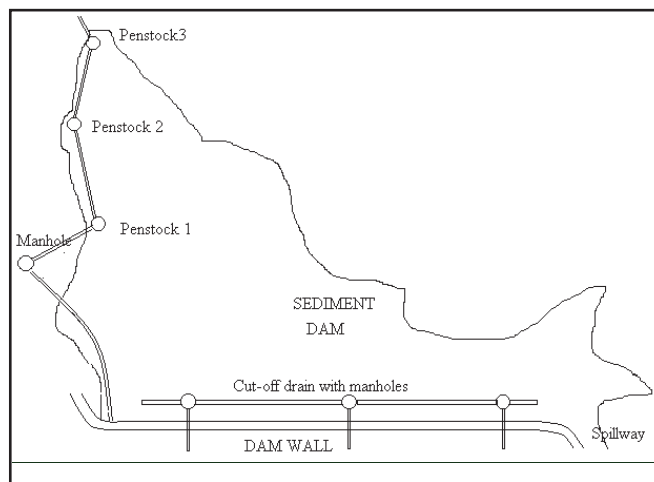
FIGURE 2. A schematic layout of the sediment dam upgrade during the 1999/2000 off-crop.

The dam wall was raised a further two metres. A new 450mm I.D. Weholite HDPE draw-off pipe was laid that spans the furthest reaches of the dam. Three new concrete penstocks feed the pipe. The penstocks have a 150mm thick inner lining constructed from concrete made using calcium aluminate cement. The HDPE pipe and the calcium aluminate cement were specified to resist the acid attack.

To counteract the effect of the rising water table on the dam wall a new elaborate cut-off drainage system was constructed upstream and parallel to the toe of the raised dam wall. The design of this system was based on experience with a similar one at the Sezela mill where piezometers, installed to measure
