MECHANICAL REDESIGN OF ION EXCHANGE RESIN VESSEL BOTTOMS AT HULETT REFINERY

L SMITH

Tongaat-Hulett Sugar Ltd
E-mail: leon.smith@hulett.co.za

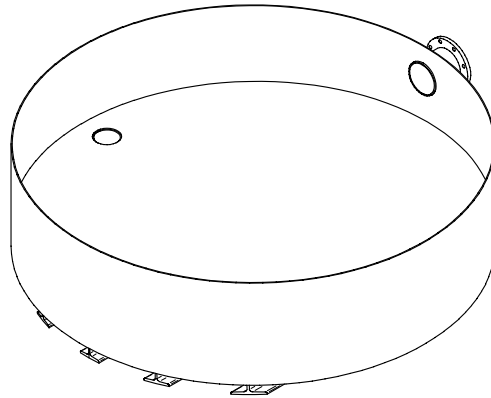
Later, one of the vessels with an Original Fabricated Flat Bottom (OFFB) (Figure 3) failed a statutory third party inspection by an approved inspection authority. A design check was done using Finite Element Analysis (FEA) and this indicated that excessive stresses existed in the shell above and below the bottom plate and support steel work of the flat plate. (See Appendix A for comments on the FEA and the third party inspection.)

Figure 3. Typical layout of the original fabricated flat bottom.

The failed OFFB was replaced by a RFFB. Appendix B provides comments on the FEA of the RFFB and reasons for its selection. Deflection indicators were installed below all the other OFFB vessels to enable a continuous monitoring of the integrity of all the remaining original bottoms. Fatigue failures of the remaining OFFBs are expected at random.

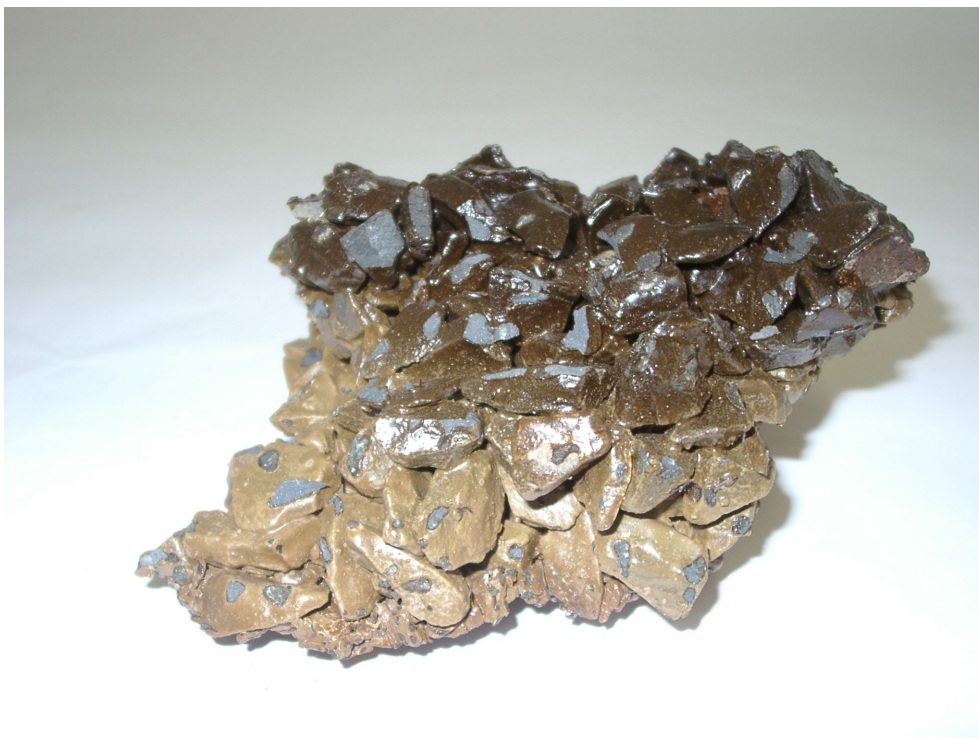
No distributor failure occurred on the primary vessels with the CDEs from 1978 to 1999 however, failures started to occur on these bottoms after 1999. When one of the distribution systems was changed on this type of vessel, it was found that the top layer of concrete with an epoxy additive was severely corroded under the protective layer (Figure 4).

Figure 4. Corroded concrete.

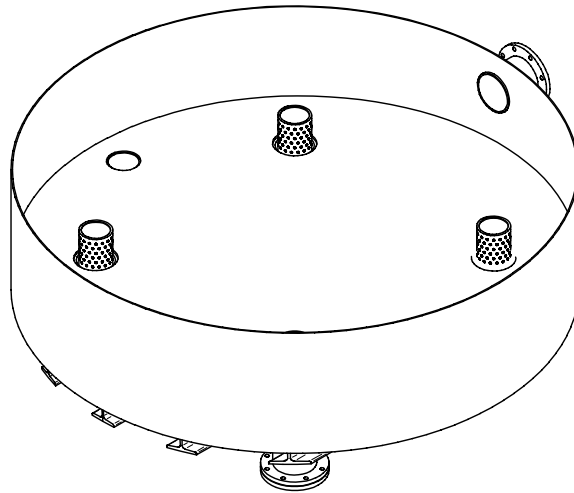
Figure 5. Redesigned fabricated flat Bottom with four top hats installed (stones omitted for clarity).

Redesigning started on the distribution system after it failed in the vessel with the RFFB. It was decided to use a system similar to the one in operation at Afprod Glucose plant in Germiston, which had given no problems since installation. This system, THSB, consists of a “top hat”, layers of graded stone above the “top hat” to form a stone bed and then the resin above the stone bed. The “top hat” installation forms the new collection point of the bottom distribution system. The stones form a filter that prevents the resin beads from escaping through the “top hats”. An additional strake was added to the bottom of the resin vessel to increase the height and volume, to compensate for the loss of resin volume created by the stone fill. A “top hat” installation with four “top hats” (Figure 5), was done on a spare RFFB before it was installed on one of the secondary vessels.

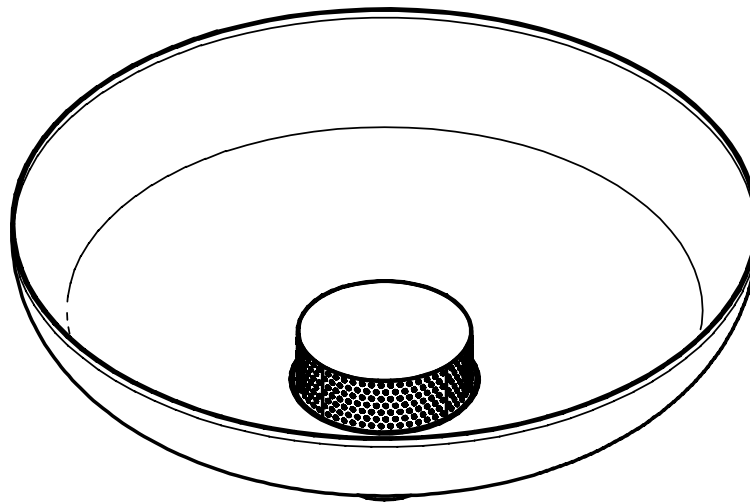
Figure 6. Torispherical dished end with a single top hat installed (stones omitted for clarity).

An increase of the failure rate of the distribution system in the primary vessels with the CDEs prompted a redesign of the distribution system in the vessels with these bottoms. A single large “top hat” was installed at the bottom of the dished end (Figure 6). The height of the vessel was also increased to allow for the loss of resin volume created by the stone bed that was loaded above the top hat.

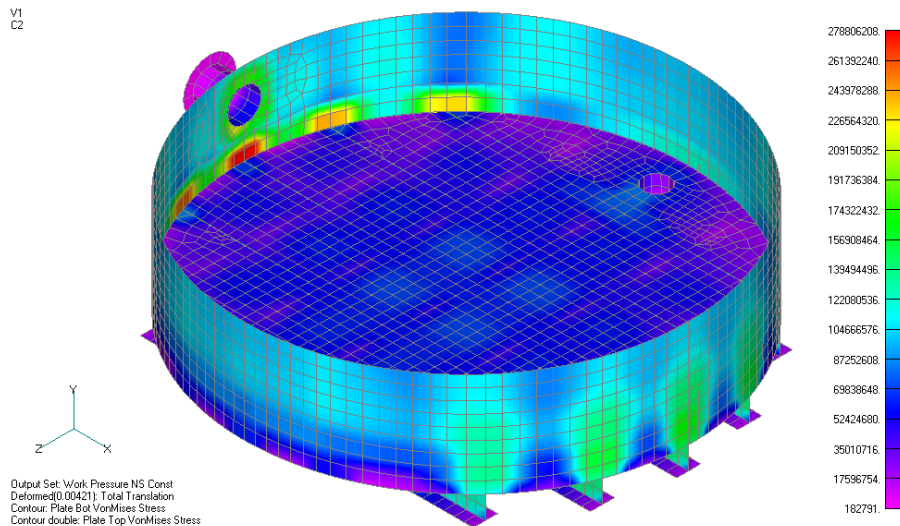
A FEA was done on the original fabricated flat bottoms to determine the expected deflections under normal operating pressure and test pressure. This FEA indicated very high stresses in the shell and support beams, as high as 280 MPa, which exceed the allowable stress of 150 MPa for “boiler plate” (BS1501-151-430A) up to a thickness of 40 mm and below a temperature of 100°C as specified in (BS5500: 1999 Specification for fusion welded pressure vessels). These high stresses indicated that a redesign of the bottom would be required.

A numerical model was generated using MSC visual Nastran. This model was meshed, loaded with operating and test pressures, constrained and analysed. Figure A1 shows the calculated Von Mises stresses on the bottom when the operating pressure is applied, which is typical of all the plots obtained, during the analysis of the various options. The calculated deflections and maximum Von Mises stresses are shown in Table A1.

Figure A1: Von Mises stresses in original fabricated flat bottom (operating pressure applied).

The fabricated bottom was redesigned using FEA. Different plate thicknesses and different support beams were used in a trial and error process until the calculated stresses reduced to below the maximum allowable stress. The stresses were reduced to below 148 MPa under operating pressure. This calculated value is below the allowable 150 MPa design stress as specified in the design code. The calculated deflections reduced to 2.47 mm and 3.71 mm under operating and test pressures respectively as shown in Table B1.
