# FIRST IMPRESSIONS OF ADI CHAIN INSTALLED IN THE AMATIKULU DIFFUSER

REIN M<sup>1</sup>, SMITH L<sup>2</sup>, STRACHAN B<sup>3</sup> and WIRMINGHAUS R<sup>4</sup>

<sup>1</sup>Tongaat Hulett Sugar, Private Bag Amatikulu, 3801, South Africa

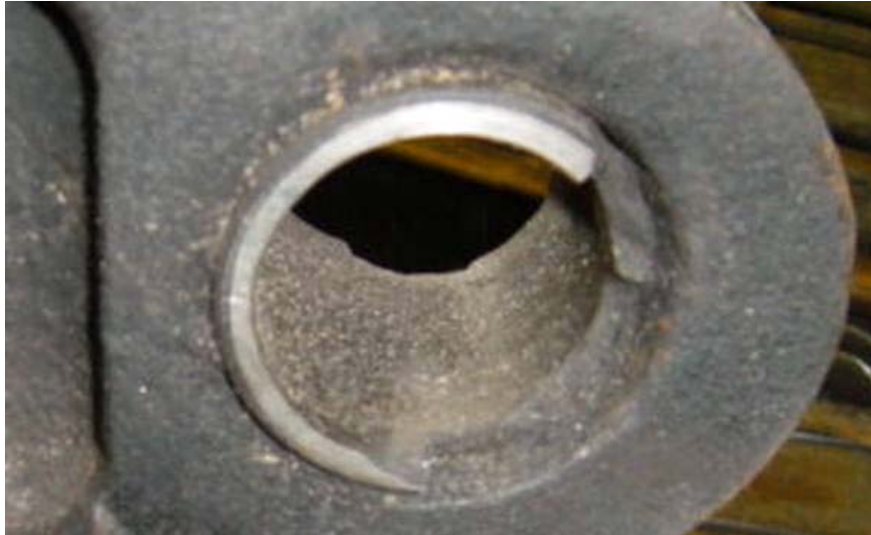
The links have also suffered corrosion-erosion around the bush journals (see Figures 1 and 2). Shown in Figure 1 are typical examples of the corrosion-erosion that is present on most of the old Ausrex links. The corrosion is deepest close to the bush, and varies from 3-6 mm depth. The corrosion weakens the link by reducing the cross-sectional area, it also causes the bush-ends to crack (Figure 2). The inner link in Figure 2 shows initial stages of corrosion around the bush. Note that the bush is cracked on both ends; this introduces bending stress in the pins and the links.

**Figure 2. Worn Ausrex inner link.**

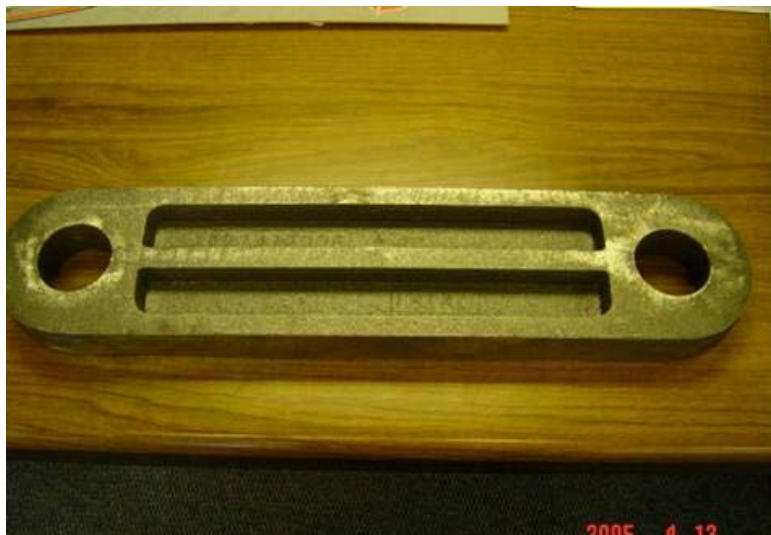
The slight warping of the outer links was corrected by simply machining the links to size after allowing a substantial casting allowance. The pattern of the side-link has now been altered to introduce a rib parallel to the link flanges, which has eliminated the warp without adding excessive weight to the chain (see Figure 3).

**Figure 3. Experimental side link with added centre stiffener.**

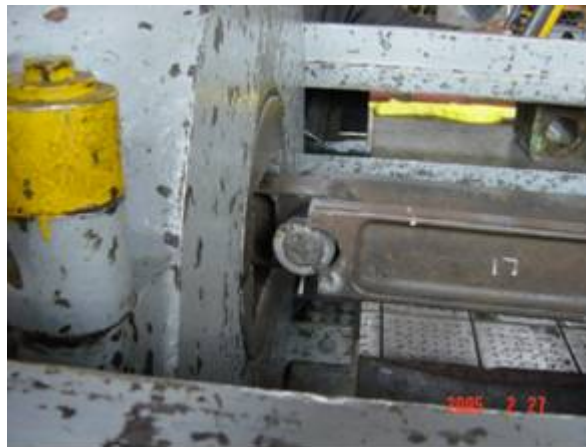
Figure 4 shows the first sample, failed at the bore of one of the outer links. Figures 5 and 6 show the mating fractured planes of the old links. Figure 5 is most interesting as it clearly shows inherent defects in the cast, which were not apparent on visual inspection before testing. The defects have possibly been developed further by corrosion. Note the pattern of the hollows running at 45° from the bottom of the corrosion crater close to the bush. The new cast links initially slipped in the machine jaws under tension, and were then rotated 90° so that the jaws could grip the flanks of the flanges, which had been machined to size. The new chain broke at a safety factor of 7.5, failing on an inner block link, revealing a shrinkage defect at an ingate point (Figures 7 and 8).

**Figure 4. Failed test sample B1-B2-L1-L2.**

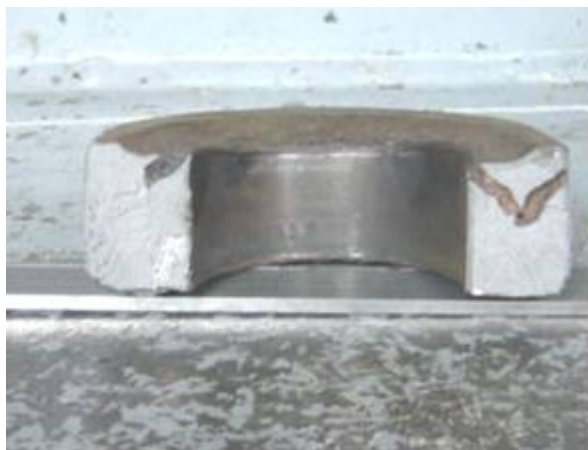
**Figure 5. Failed section B1-B2-L1-L2.**

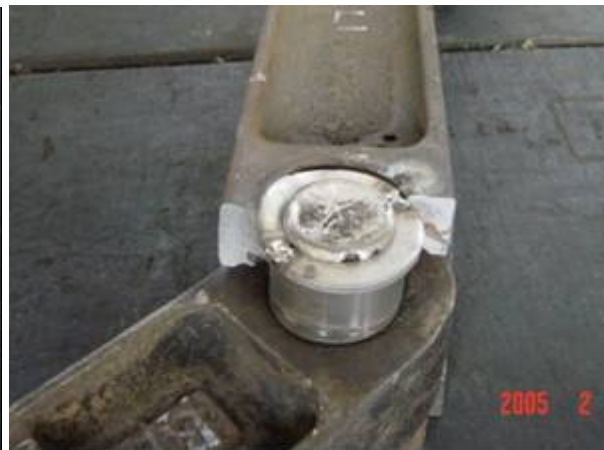
**Figure 6. Mating failed section to Figure 5.**

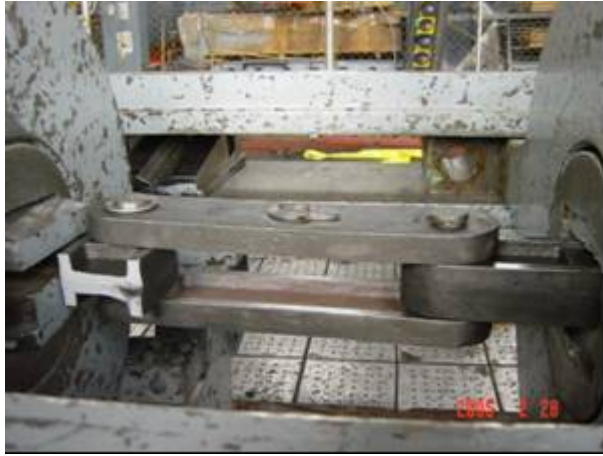
Figures 7 and 8 show the new link sample, failed at a short distance away from the bores with an obvious shrinkage defect, about 30 mm long. The strength was commendable even with the casting defect. No defect had been apparent before the test. Another tensile test was conducted on March 9 2005, where the old links which had failed to grip were re-tested, along with three new ADI links. The results of all the tensile tests can be seen in Table 1, and Figures 10 to 20 in Appendix III.

Figure 7. Failed ADI chain with defect.

detected on the outer links, but 54 of the 310 inner links were defective, and were remelted and recast. The defects were caused by the ingate pour cooling faster than the link, resulting in the ingate drawing back metal from the link. The number of ingates was increased from two to three, and were moved further away from the bores. Two feeders were also added 90° away from the ingates to assist with any further cold-drawing.

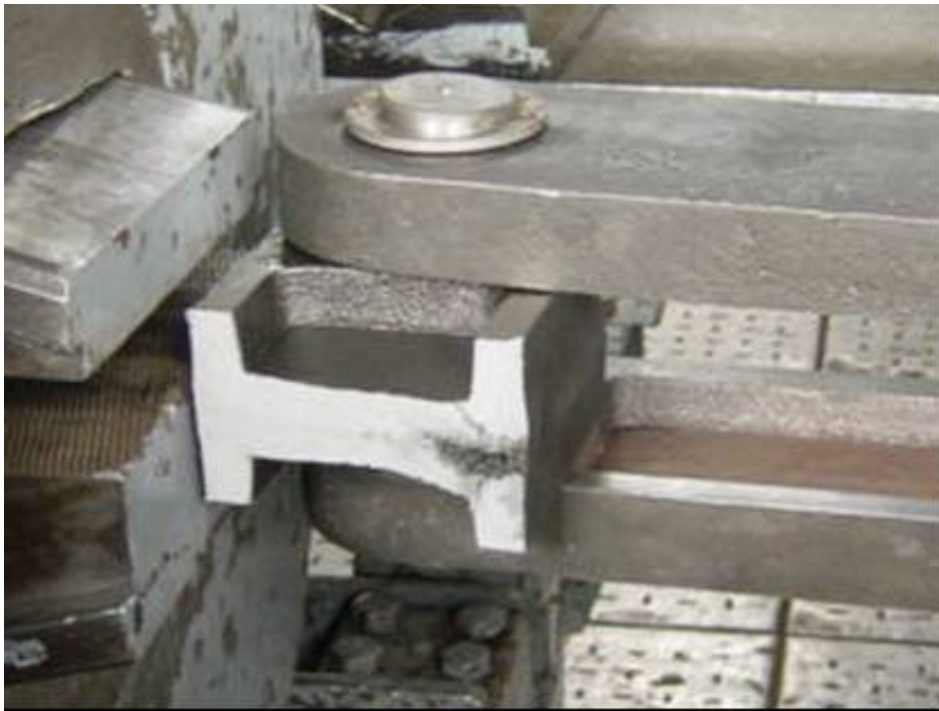
Figure 12. Failed new link 1 sample.

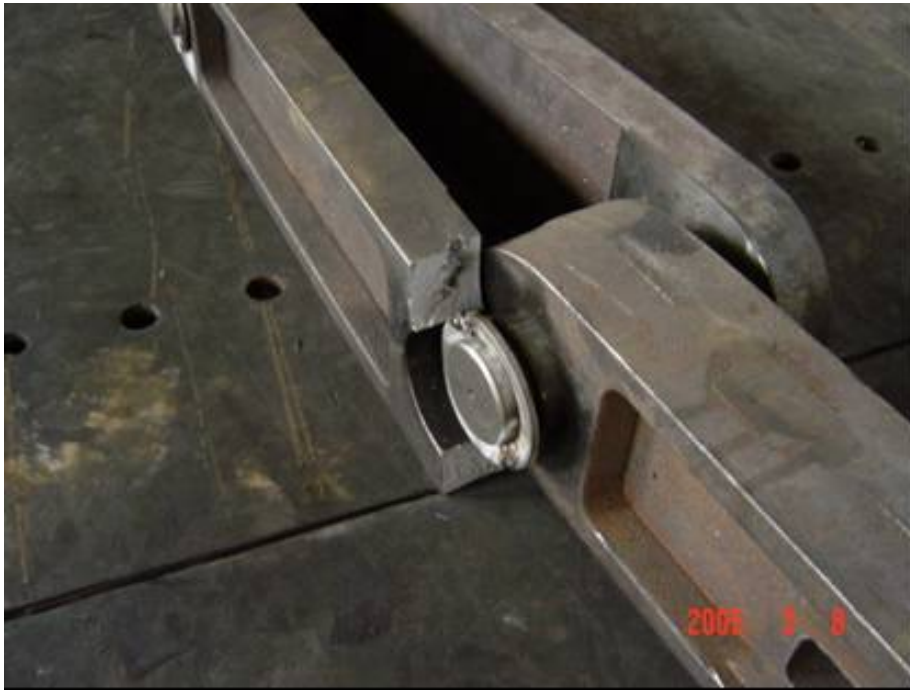
Figure 16. Failed defective new link 2 sample.

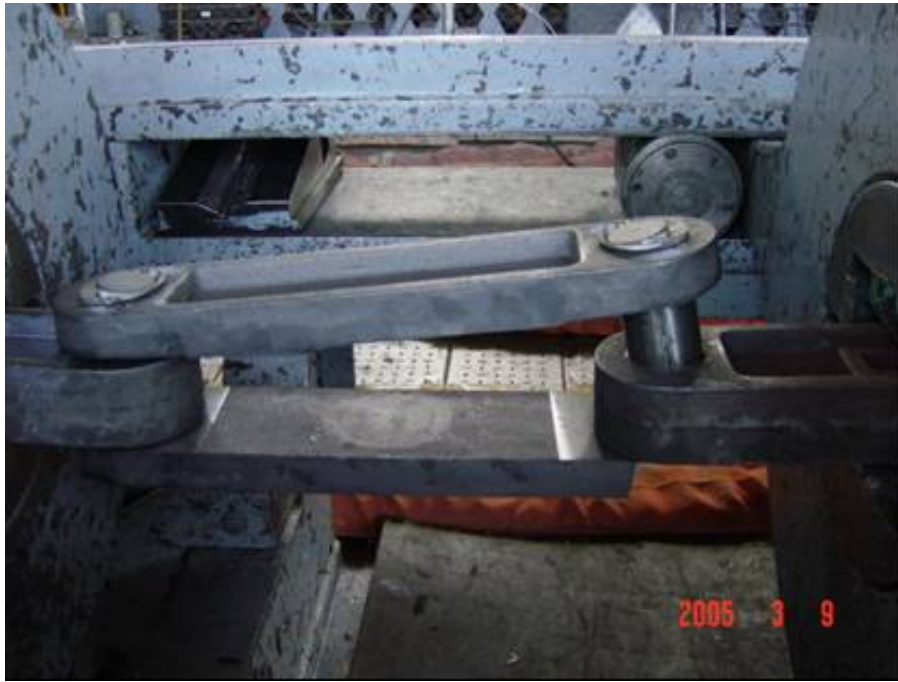
**Figure 18. Failed new link 3 sample.**
