FELIXTON MILL EVAPORATOR STATION: FINAL EFFECT PARTIAL FLASH TANK

DLAMINI BMW¹ AND BINDOFF A²

Abstract

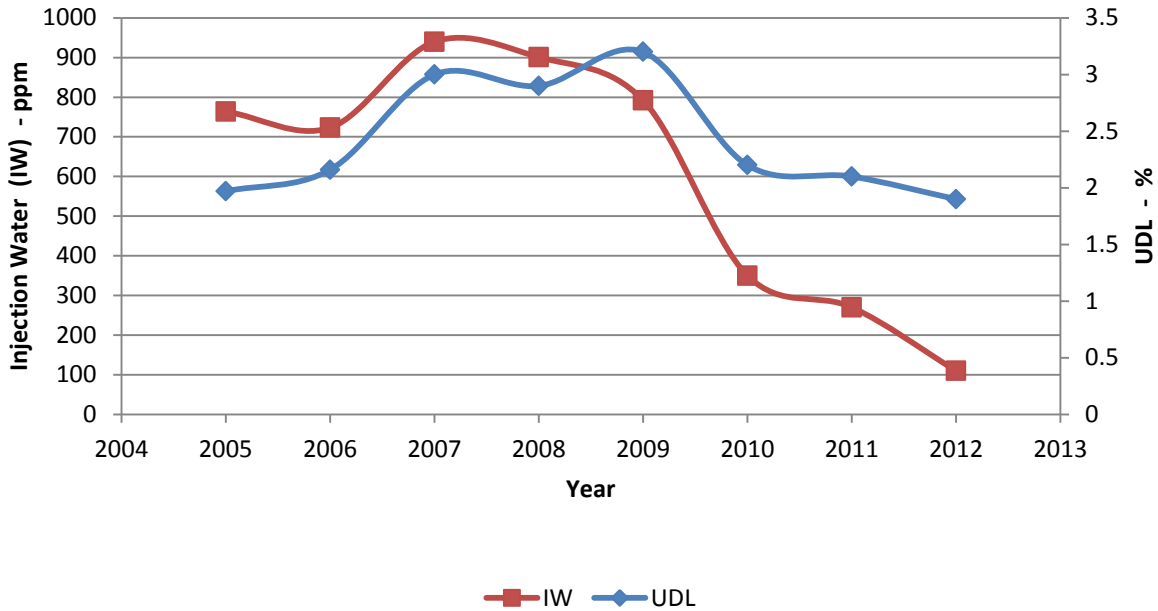
The season to-date UDL and injection water contamination for the period 2005 to 2012 are shown in Figure 2. Prior to 2005, the UDL at Felixton was generally below 2.0%. The UDL increased over a four-year period from 2005, and during the 2007/08 season it reached a high of 3.0%. The loss in this particular season was attributed to poorly fitted and damaged metex screens in the final effects. Lionnet (1984) showed that entrainment from evaporators correlated fairly well with the vapour velocity according to the relationship:

removed. UDL did not, however, return to the previous lows of <2.0% recorded in the years prior to and including 2005/06, and in 2009 again increased and peaked at a season to-date loss of 3.2%.

Figure 2. Undetermined loss and injection water trace sugar ppm from 2005 to 2012.

Contamination of the injection cooling water system was evident in the years with high UDL, with average sugar trace levels of between 700 and 940 ppm recorded during these crush periods.

Where previously 20-30 tubes had to be expanded on a weekly basis, there is now on occasion a requirement to expand only one or two tubes. The spouting in the vessel is more constrained, with very little contamination of injection cooling water occurring. The sugar trace in injection water shown in Figure 2 highlighted the reduction in cooling tower contamination after the installation of the partial flash vessels. The UDL highlighted in Figure 2 also showed an improved trend after the partial flash tanks were installed.

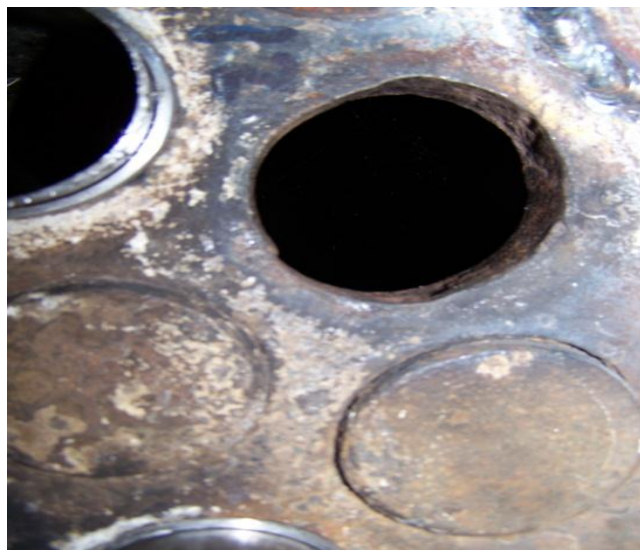
During the 2009/10 season there were numerous complaints from operational staff concerning leaking of the recently installed tubes in the final effects, especially in the area immediately above the new external feed ring nozzles. These leaking tubes were routinely either plugged or expanded during the Monday maintenance stop; some of these expanded tubes would only last a week before requiring re-expanding. The continuous re-expanding of tubes resulted in distortion of some of the tube holes, as seen in Figure 3. The tubes in severely damaged holes that would not seal were removed and the tube sheet plugged. In some instances, the plugs also did not seal adequately, and these were welded.

Figure 3. Tube sheet with distorted tube hole.

The problems associated with operating the Felixton evaporator train in the 2009 season, together with the high UDL, were identified as being caused by tube leaks in the final effects. The leaking tubes were as a result of inefficient condensate removal and feed flashing on entering the vessel. The damaged tube sheet has been repaired by re-machining the tube holes and installing sleeves to accommodate the standard evaporator tube.

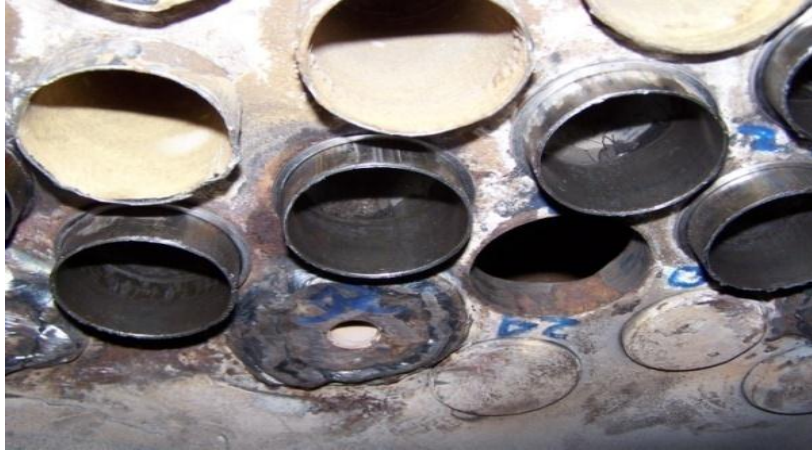
Figure 6. Tube plate holes after sleeving.
