# EPOXY COATING APPLICATIONS IN THE SUGAR INDUSTRY

By <sup>1</sup>E. KEEGAN and <sup>2</sup>T. VAN DER WALT

The maintenance costs of a sugar mill can be reduced by applying the correct coatings to corrosion-prone materials. Epoxy is one of many coatings available for application, and four specific epoxy coatings have been used extensively over the past four years in the sugar industry. The four epoxy coatings each have unique properties and areas of application, and examples of their use at Felixton are given.

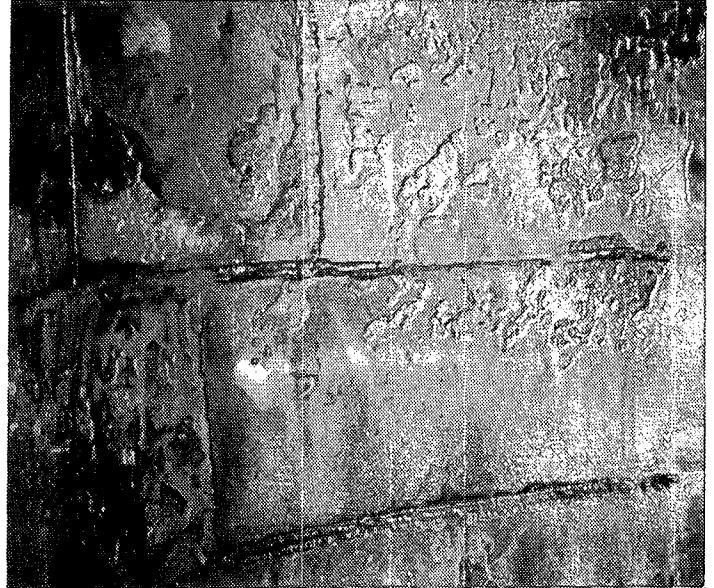
FIGURE 5 Batch pan steam chest inlet internal before epoxy coating.

In the 1987 offcrop the batch pan steam inlet chests were found to have been severely attacked by corrosion/erosion. During the 1988/89 off-crop the steam chest inlet was epoxy coated using steel trowel mix as a filler, followed by high temperature pneu-wear. The rate of corrosion/erosion of an uncoated area was monitored during the 1989 crushing season and was found to be alarmingly high, whereas the epoxy coated area needed only to be patched in places of bad application. Figure 5 shows the batch pan surface before epoxy coating was applied, and Figure 6 shows the same area two crushing seasons after the application of the epoxy coating. The coating did not need repair after the 1990 crushing season.

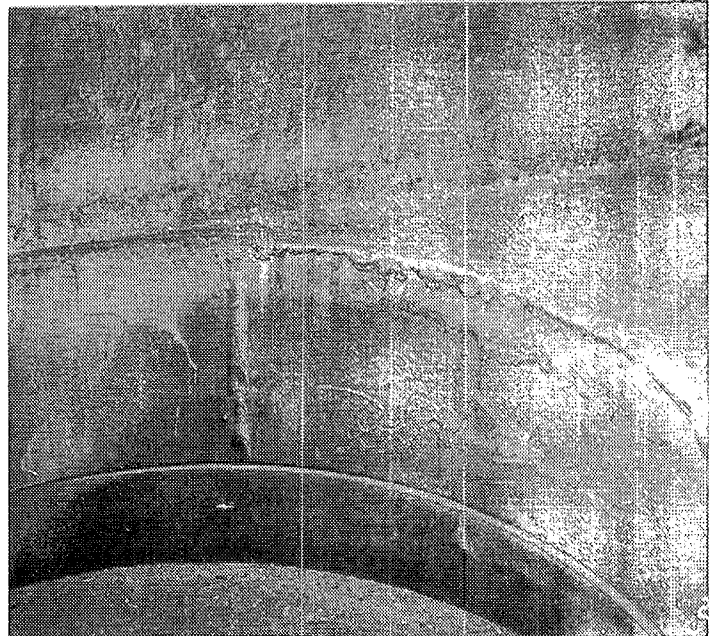
FIGURE 6 Batch pan steam chest inlet internal after epoxy coating.
