STEPS TAKEN TO IMPROVE REFINED SUGAR TURBIDITY AT THE PONGOLA SUGAR REFINERY

MASEKO Q, SINGH R AND MOTSA N

Tsb Sugar, PO Box 23, Pongola, 3170, South Africa
masekoq@tsb.co.za singhr@tsb.co.za Motsan@tsb.co.za

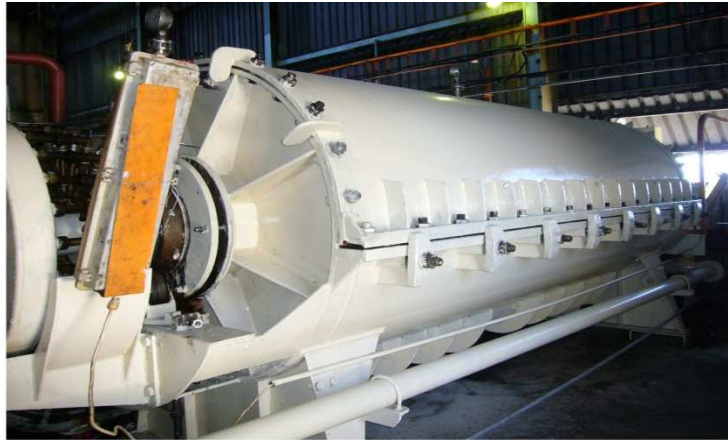
Figure 2. Rotary pressure leaf filter at Pongola.

Pongola refinery uses rotary leaf pressure filters for the filtration process followed by candle filters that act as the goalkeeper for the removal of turbidity from the filtered liquor prior to crystallisation. The rotary pressure leaf filters are used by many of the South African sugar refineries for carbonation and sulphitation filtration. Filtration in a pressure leaf filter is essentially solids retention on a porous filtration medium supported on a permeable membrane. This permeable membrane is generally a polypropylene filter cloth which in turn is supported on a rigid frame. The technique employed at the Pongola refinery uses the precipitate formed during carbonation as the filter medium whilst on

the secondary filtration stage pre-coat is used to form a filter medium on the filter cloth surface. Figures 2 and 3 show examples of the filters installed at Pongola.

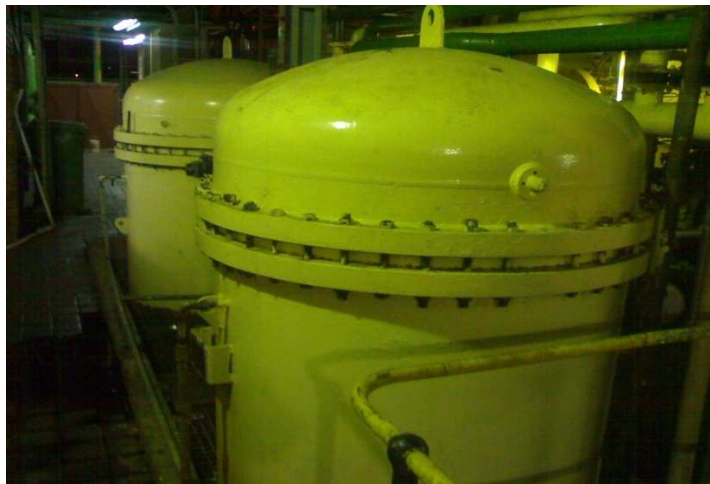
Figure 3. Polish candle filter at Pongola.

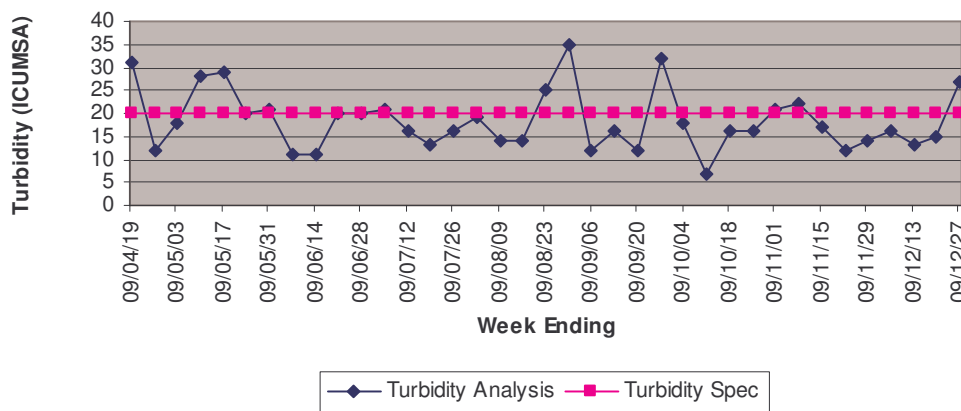
Figure 4. 2009 season refined sugar turbidity.

Figure 4 shows refined sugar turbidity for the 2009 season.

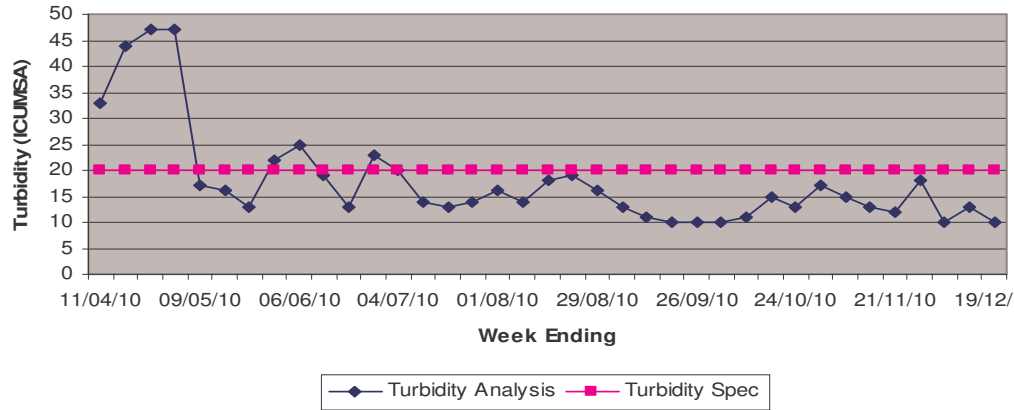
Figure 5. 2010 season refined sugar turbidity.

The refined sugar turbidity for the 2010 crop is presented in Figure 5.

The results indicate that turbidity had slipped and was above specification for the first four weeks of the 2010/11 crop. The demand for export sugar necessitated further filter optimisation work. A project management approach was adopted to address the shortcoming. Using knowledge from previous investigations in 2008 and 2009, a team of operations and engineering staff ‘homed-in’ on the filter station. It quickly emerged that off-crop filter maintenance had declined due to the loss of experienced staff.
