# SOME IMPROVEMENTS IN THE DESIGN AND OPERATION OF COAL FIRED BOILERS

By JOHN X. SHUM

*Hulett's South African Refineries Limited*

This paper deals with five problems experienced in the operation of coal fired boilers and the methods by which these problems were overcome. The paper is divided into five sections, each dealing with a specific problem, although some of the problems are inter-related. Drawings are diagrammatic but charts shown are from the boiler instruments.

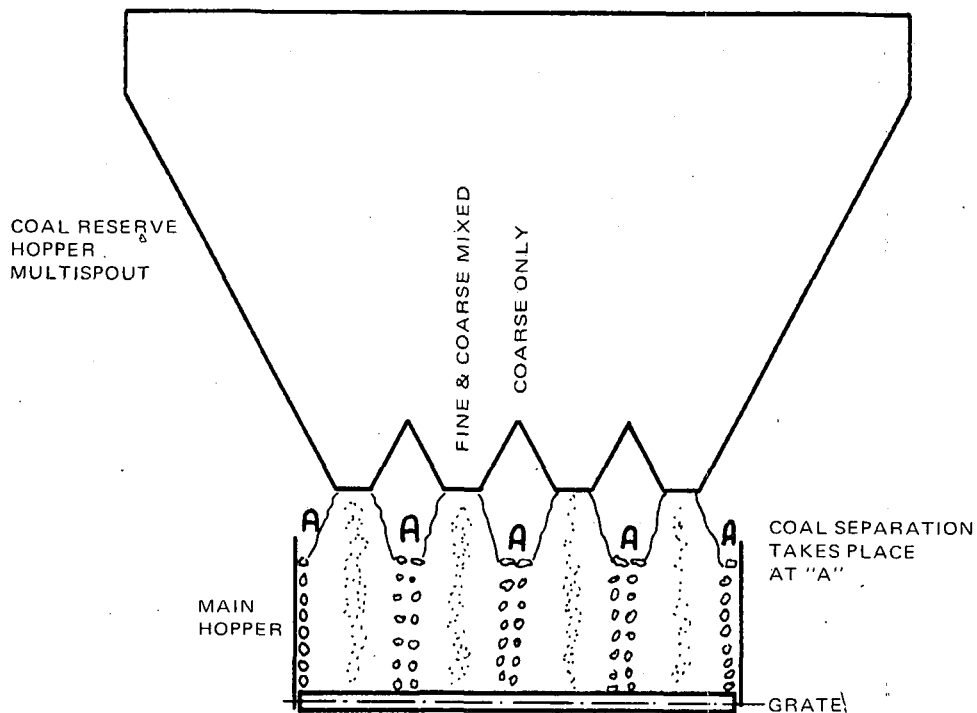
**DIAGRAM NO. 2:** Diagram of coal reserve hopper (multi-spout), main hopper and coal on grate.

pieces to run down the side of the cones formed while the finer material remained static, this being coal separation. This caused a variation in the porosity or permeability of the coal on the grate with resultant draught problems.

As the coal ignited and burnt the forced draught naturally took the path of least resistance, and the major portion of air passed up through the section of grate covered by the larger pieces which had the greater porosity. Since the draught was applied at a pre-determined pressure and volume and since it could only slightly penetrate the dense mass of fines, there was an increased volume and consequently an increased velocity of air passing through the sections of larger pieces of coal. Any finer particles adhering to or separating off these larger pieces of coal then ignited and were carried by the high velocity draught up through the furnace and deposited on the overhead generating tubes while still in their plastic state. When striking the comparatively cooler surface of the tubes they were chilled and adhered to this surface, this being the beginning of birdnesting. This action had a cumula-

tive effect until ultimately all tube passages were choked. See photograph "A".

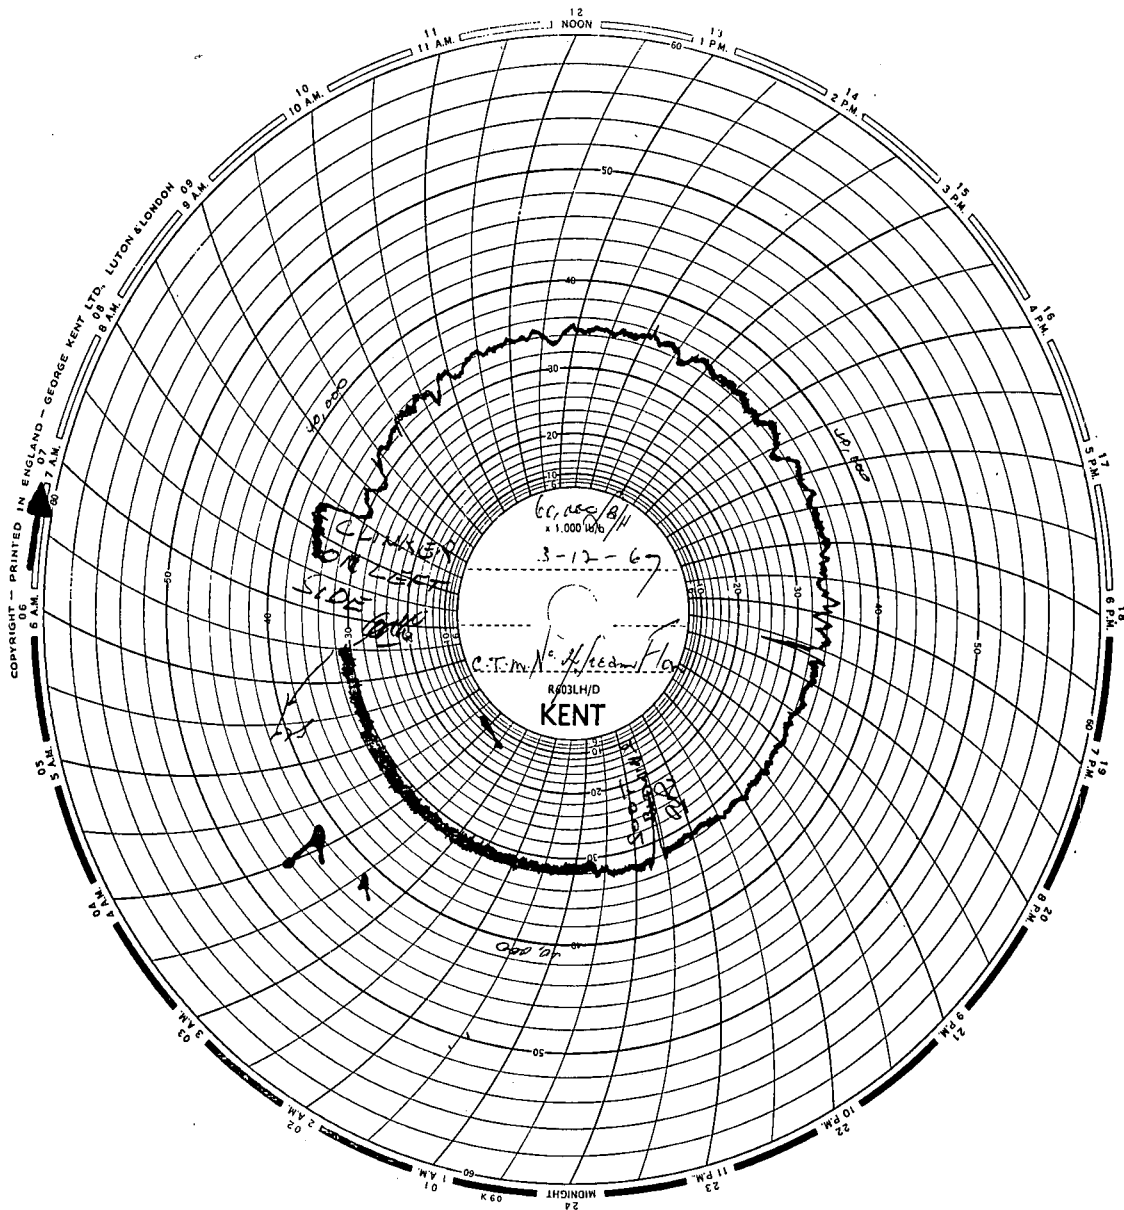
CHART 4

The charts shown indicate the progressive deterioration of steam flow from the boiler due to fouling up of the tubes by birdnesting.

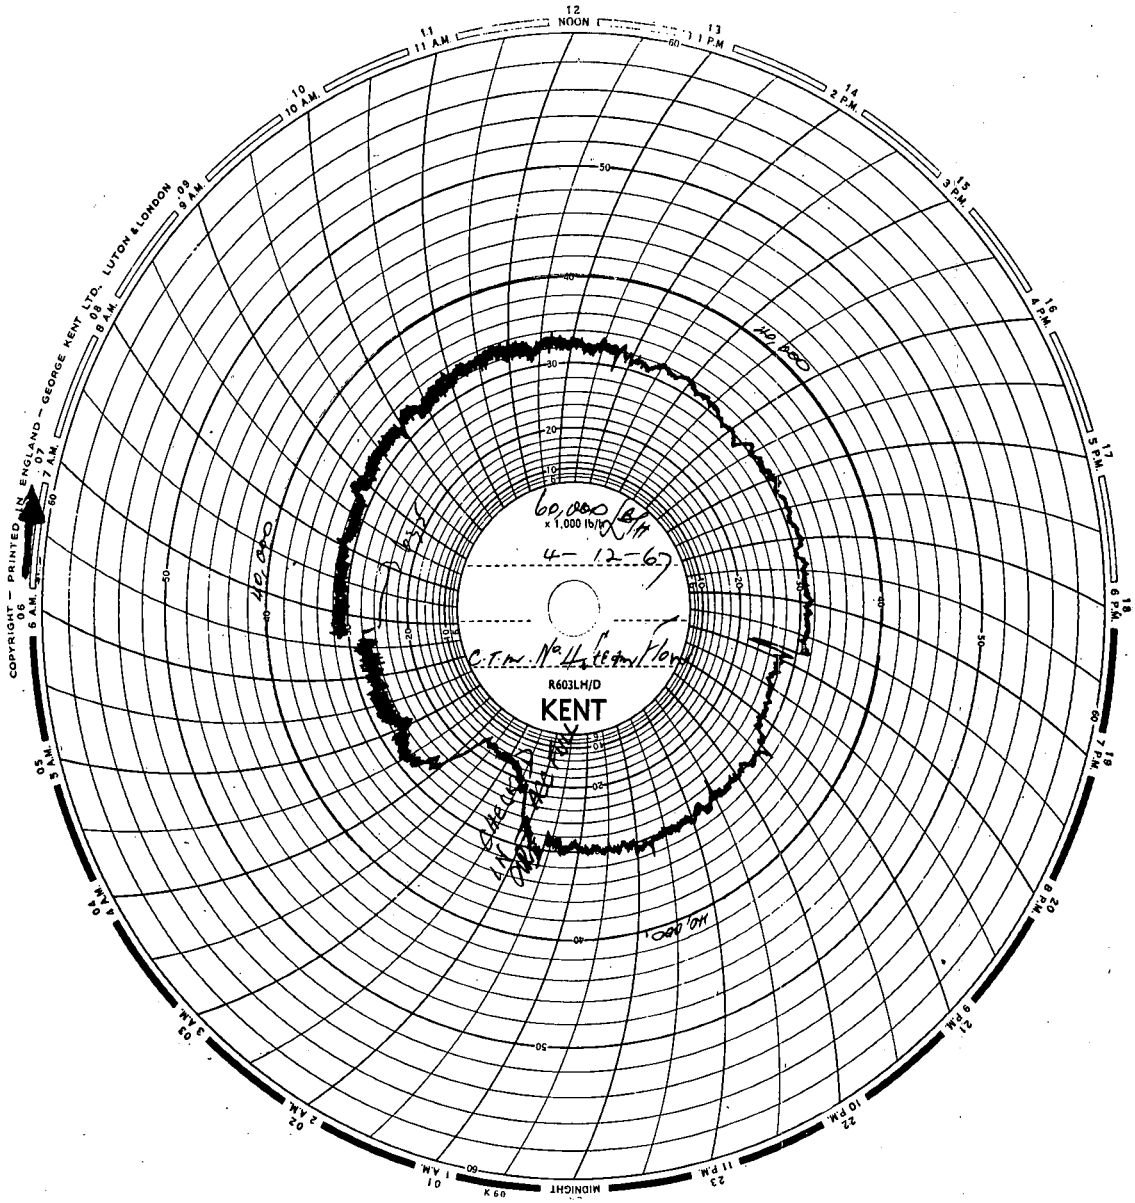
CHART 5

As can be seen from Chart No. 5 the boiler gave its maximum steam output again after cleaning.

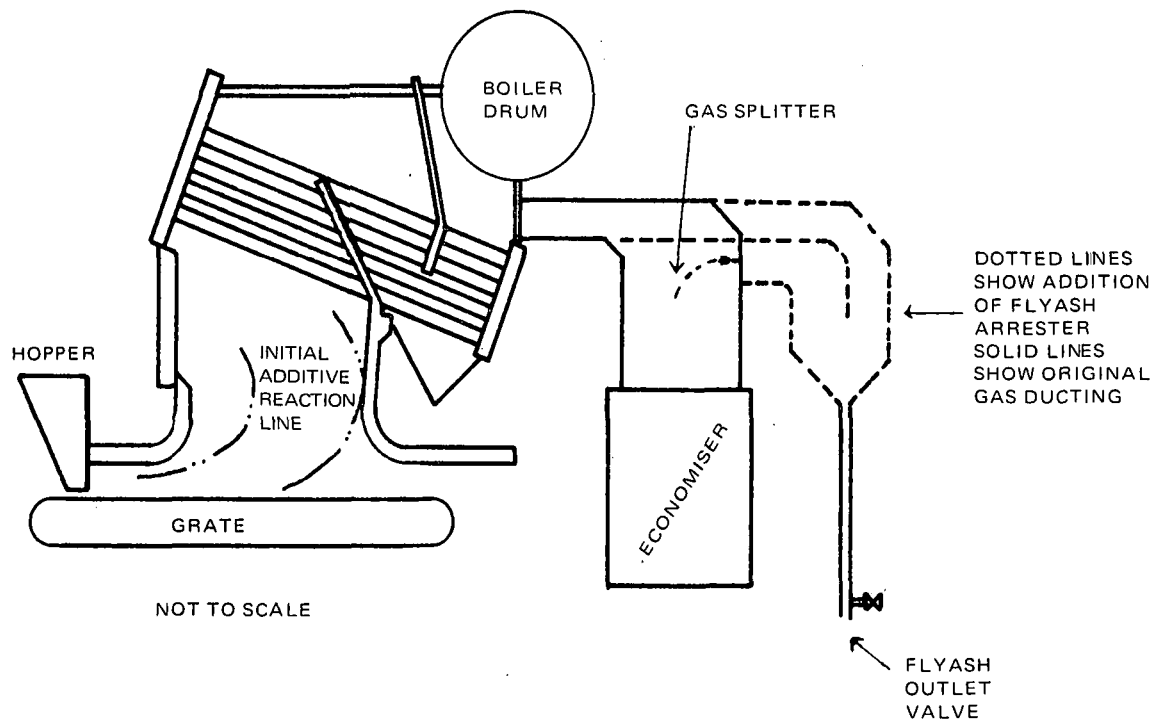
DIAGRAM NO. 4: Section through B & W showing reaction of additive.

on the boiler under additive test the entire furnace was now clean and even the top brickwork on the ignition arch was becoming cleaner. All tubes were clean, rear arch was clean down to the brickwork and overhead generating tubes showed no sign of choking up.

Examining the gas flow through the boiler it was noticed that the gases changed direction before entering the economiser and the lower portion of this last pass was always full of flyash. This then was the principle which had to be applied to the B & W boilers and it has been achieved as shown in diagram 4. Diagram 5 shows the gas flow in the Stirling boiler.

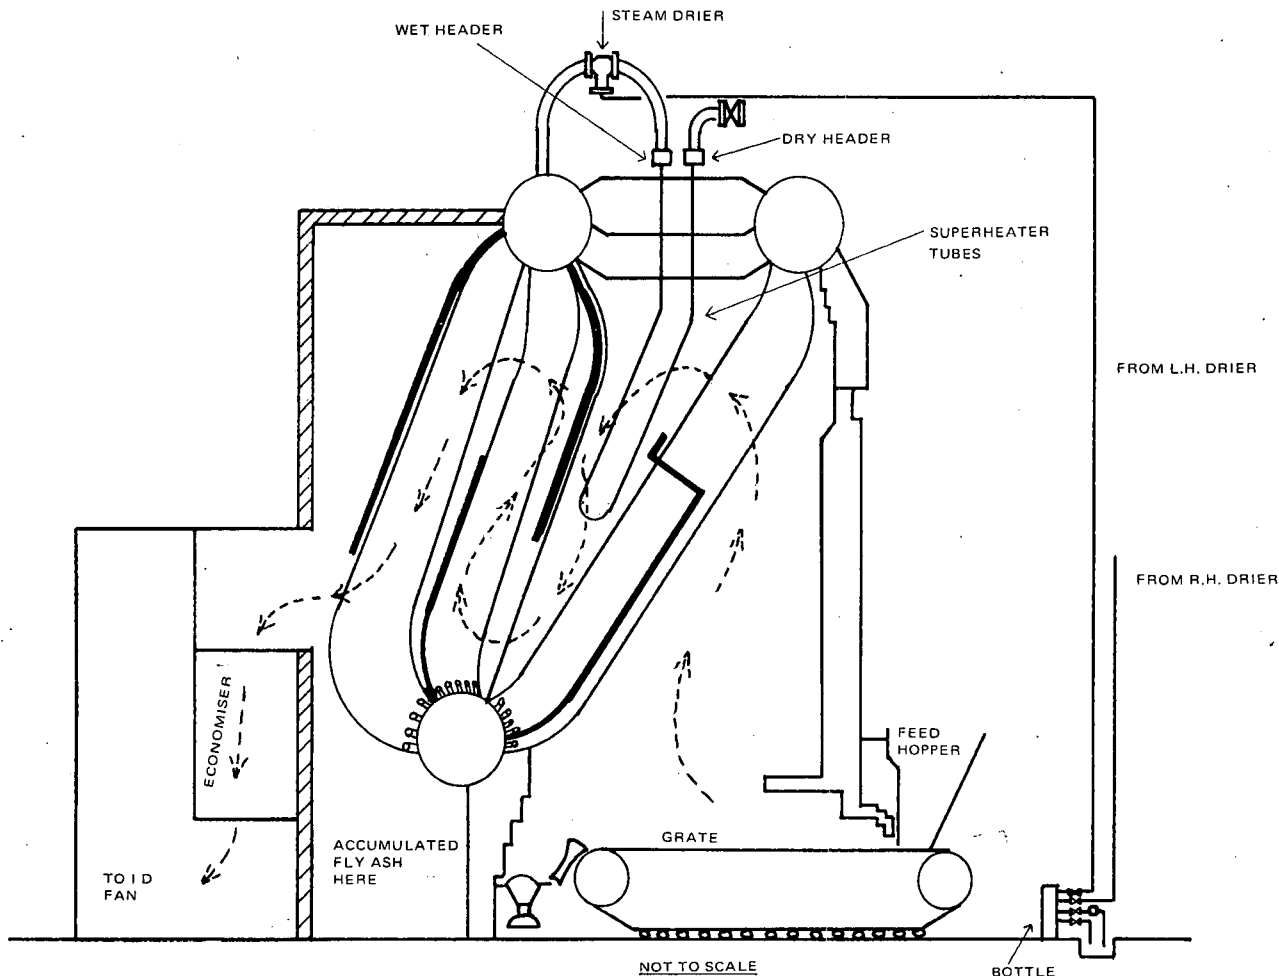
DIAGRAM NO. 5: Cross-sectional drawing of Stirling boiler,

During our annual shutdown it was observed that the finned tubes on the economiser of the Stirling boiler were clean whereas those on the B & W C.T.M. boilers were very dirty. All boilers used the same coal and steamed under similar conditions so the problem now was to establish the reason for the economiser being clean on the Stirling boiler. This economiser was an addition to the boiler and not part of the original installation.
