# FIRST IMPRESSIONS OF ADI CHAIN INSTALLED IN THE AMATIKULU DIFFUSER

REIN M<sup>1</sup>, SMITH L<sup>2</sup>, STRACHAN B<sup>3</sup> and WIRMINGHAUS R<sup>4</sup>

<sup>1</sup>Tongaat Hulett Sugar, Private Bag Amatikulu, 3801, South Africa

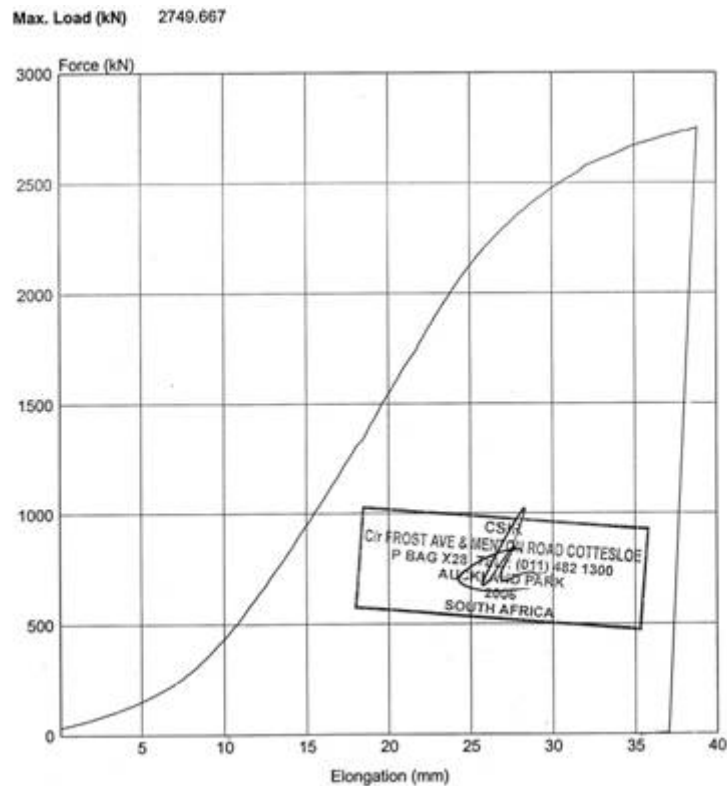
**Figure 9. Typical stress-strain graph of the ‘new link 1’ sample shown in Figures 7 and 8.**

Figure 9 is a typical stress-strain graph of the tested links. There is an initial elongation at low load which gives way to a linear stress-strain relationship, until the link assembly starts to yield plastically. The 'reduction' in strain after the breaking point is due to the 'spring' in the machine itself<sup>2</sup>.

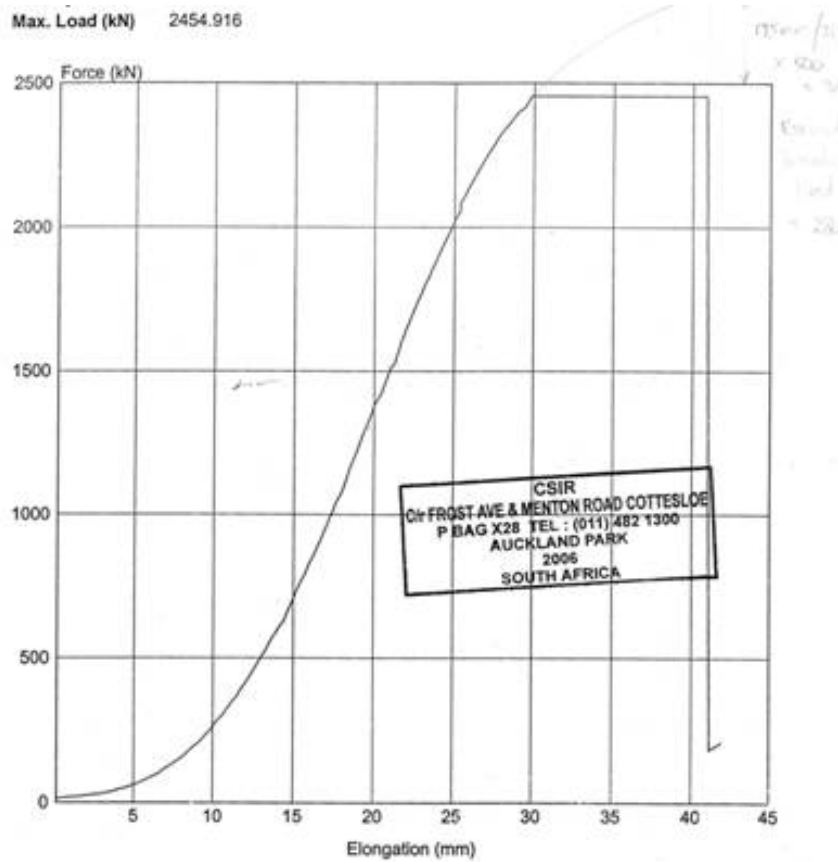
**Figure 19. The stress-strain graph of the new link 3 sample, with the incorrectly scaled graph.**

The breaking load in figure 19 was estimated from the graph as 2800 kN.
