# BELT INTERCARRIER

By F. FOKKENS

Melville Sugar Estates

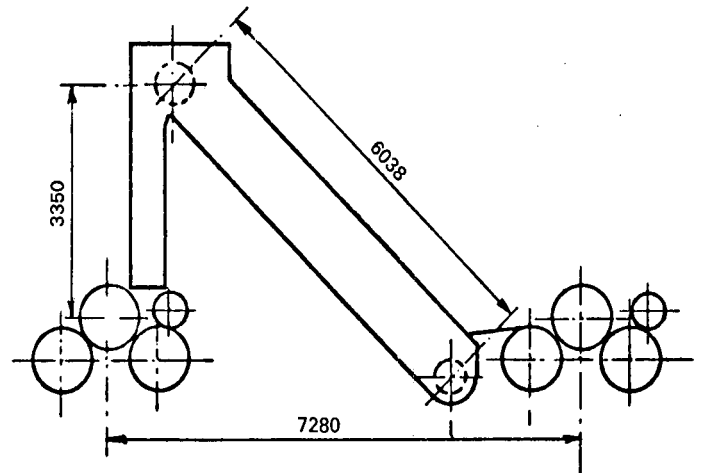
FIGURE 1 Basic Design Dimensions No. 3 IntercARRIER.

The existing units at Reunion worked effectively with  $30^\circ$  incline so it was decided that  $27^\circ$  should be the target with small variations if necessary. Chute level was therefore dropped from 3,4 m to 2,4 m above the feedroller, with a centre distance of 7,28 m between the mills. Total belt length required for the installation was only 14 m (12,2 m circumference) and a width of 1 910 mm (for 1 675 mm wide mill). A Meinecke type discharge chute on No. 2 mill delivers the bagasse to the belt under an incline of  $\pm 35^\circ$  from the discharge opening. A medium speed kicker, breaking up all lumps of bagasse, accelerates the bagasse from the Meinecke chute to the medium

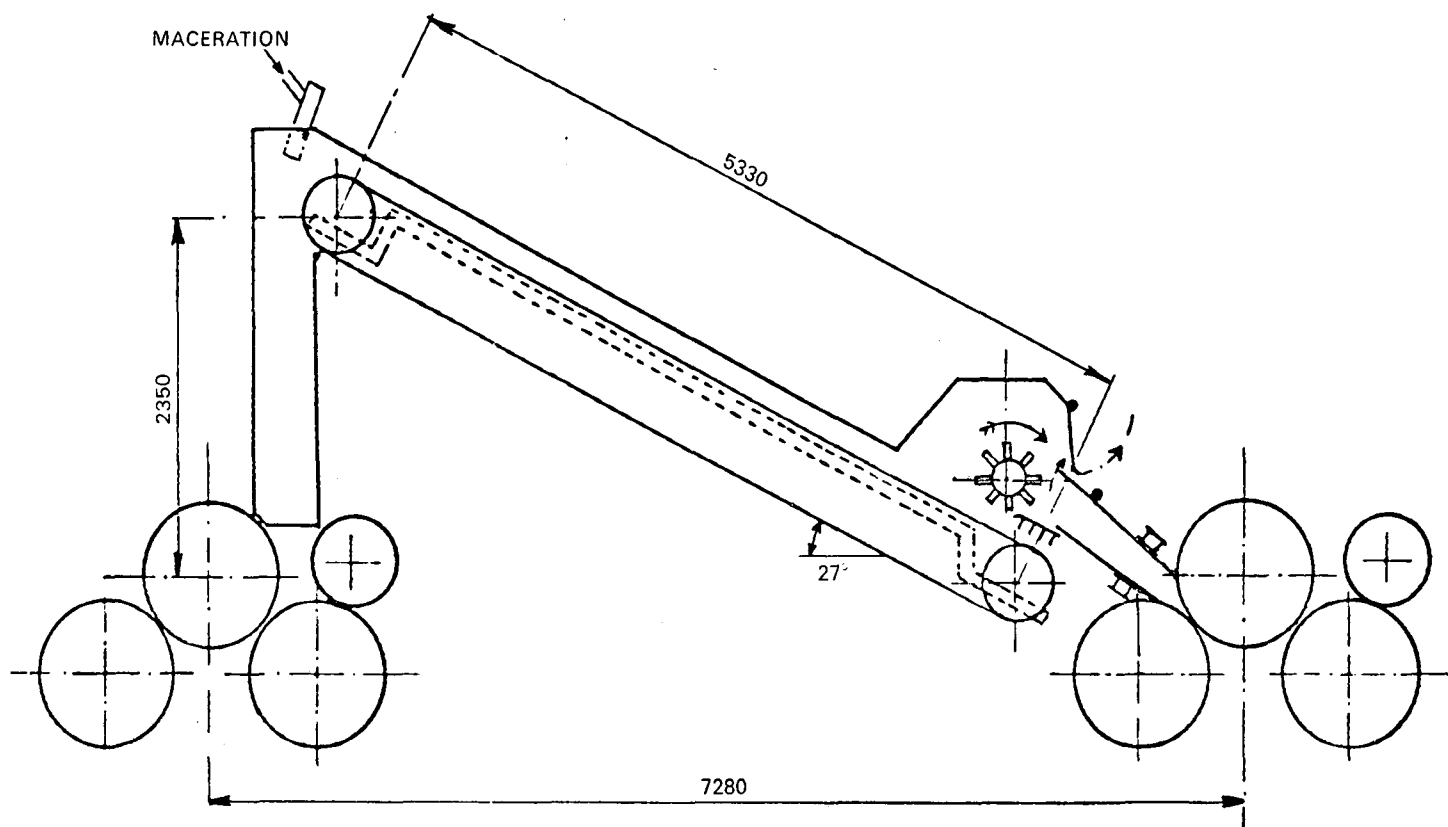
FIGURE 2 "Riviere" Intercarrier at Melville Sugar Estates.

## Construction (see Fig. 2)

speed belt. As a result of the velocity all bagasse is flung from the belt into the chute, and a light rubber scraper ensures a clean return section of the belt.
