# EXPERIENCES WITH AN EMERGENCY SPRAY COOLING POND

By A. H. WINTERBACH

*Transvaalse Suikerkorporasie Beperk, Malelane*

The design and performance of an emergency spray cooling pond, which was constructed at ML during 1983, are discussed.

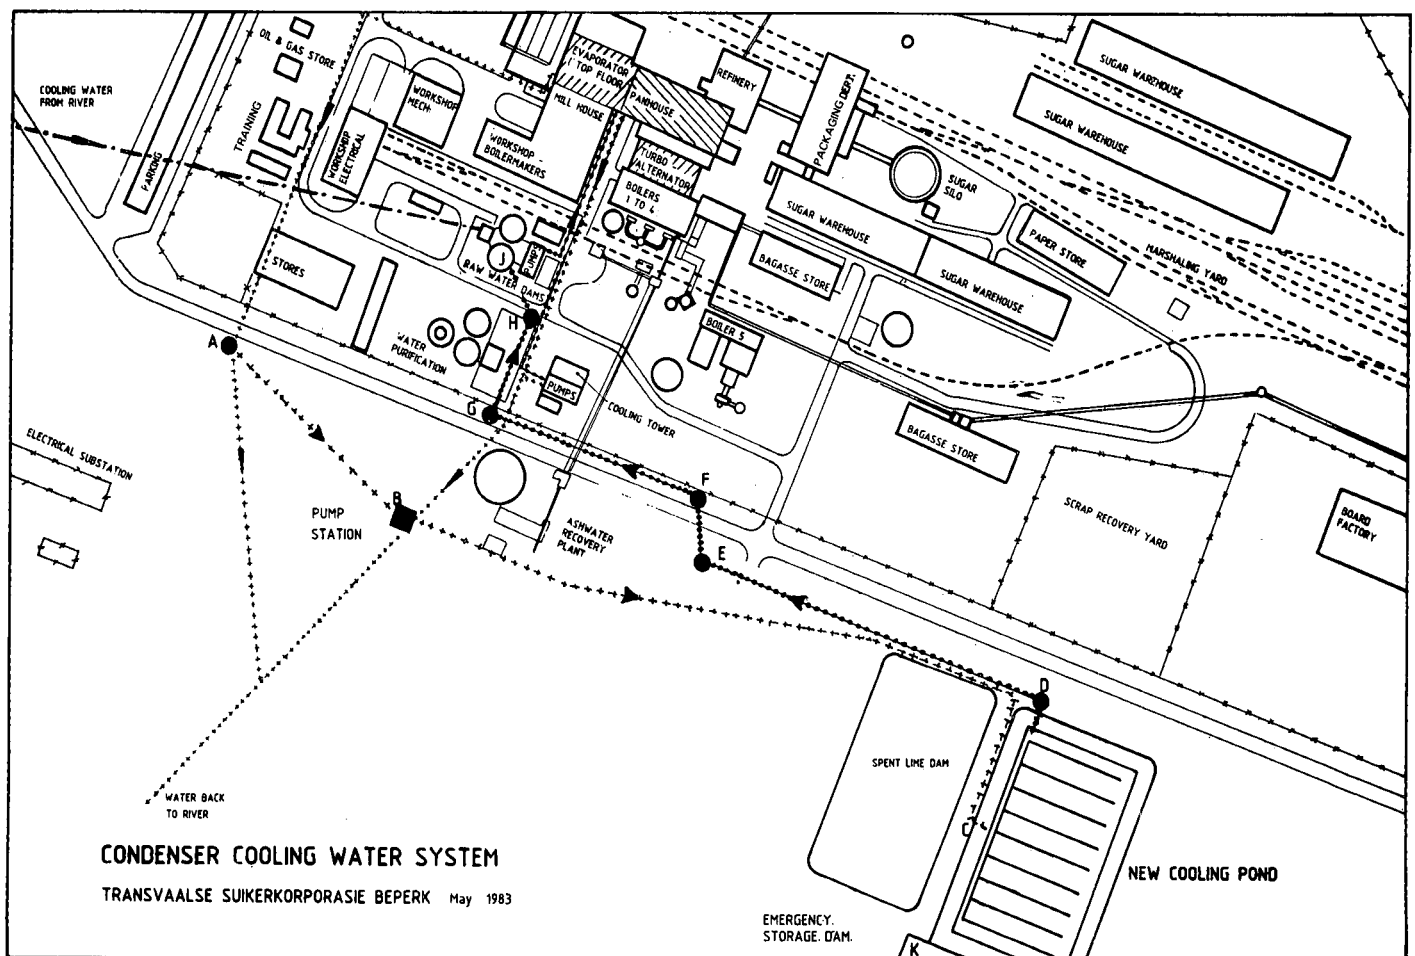
FIGURE 1 Condenser cooling water system, new cooling pond and piping

Cooling water for condensers at ML is derived from two sources (see Figure 1):

- directly out of the Crocodile river at 2 731 m<sup>3</sup>/h and
- from a three-cell cooling tower at 1 320 m<sup>3</sup>/h.

The system that was designed catered for a water flow of 2 079 m<sup>3</sup>/h which, with the existing cooling tower of 1 320 m<sup>3</sup>/h, gave a total of 3 399 m<sup>3</sup>/h which would ensure a cane crushing capacity of 280 tch. ML's normal crushing rate is 325 tch but as a result of the droughts, this was reduced to 280 tch. The system (see Figure 1) consisted of:

The pond was constructed such that when it was full it would be at the same level as the cooling water pump station feed dam (J) when it was also full. Water could thus flow in either direction in the gravity main (D E F G H J).

- Gravity main (D — J): this pipeline necessitated the use of 900 mm asbestos cement pipes with a total length of 560 m. Two underground road crossings had to be constructed together with four towers at turning points. There was usually a change of level at a turning point. Special bends could not be made in time and thus it was opted for open top towers.
- Emergency storage dam (K): during the design stage it was realized that some storage facility would have to be provided. A disused dam adjacent to the new spray pond was converted into a dam 120 m × 75 m × 5 m deep, giving an 11 hour full reserve.
- The capital cost for the project was approximately R300 000.
