## PANFLOOR MODIFICATIONS THAT IMPROVED PERFORMANCE AT AMATIKULU MILL

The Amatikulu mill panfloor had areas which needed design improvements for efficient running of the factory. The pipes for venting heavy and light incondensable gases were separated in all the 85 m<sup>3</sup> batch pans to improve the rate of heat transfer. Changes made to the molasses feed ring in the main C-massecuite pan improved circulation and reduced massecuite temperatures, thereby reducing possible Maillard reactions. The condensate removal system in the vacuum pan was modified, and this resulted in reduced water hammer and improved pan circulation. The injection water exit troughs in the internal condensers of the B- and C-massecuite pans were extended to eliminate intermittent flooding of the pans. This paper reviews practical work done during the 2006-2007 off-crop which led to improved sucrose recoveries at the Amatikulu mill.

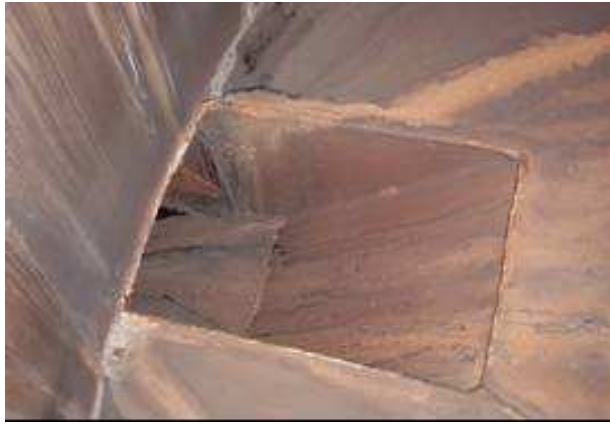
At times the B-massecuite pan at Amatikulu experienced flooding. This occurred whenever the condenser demanded more water than it could discharge. The excess water diluted the massecuite and caused an increase in boiling times. It was thought that the mouth of the outlet was too small to allow the injection water to exit the trough without creating turbulence. Poor removal from the internal condenser would cause the accumulated injection water to overflow back into the pan. This was confirmed by doing trials after factory shutdown. It was found that the injection water valves could be opened only up to a point, beyond which water would flood back into the inside of the pan. This problem was overcome by extending the length of the injection water trough from 500 to 1280 mm, which more than doubled the area of the outlet trough and made it easier for the water to flow out of the condenser (Figures 4 and 5).

**Figure 4. Unmodified injection water trough.**

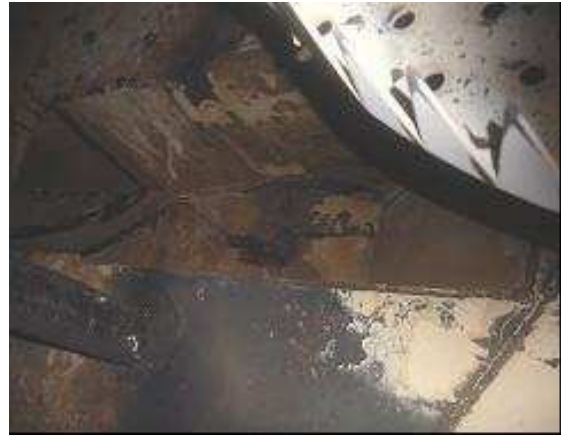
**Figure 5. Extended feed water trough.**

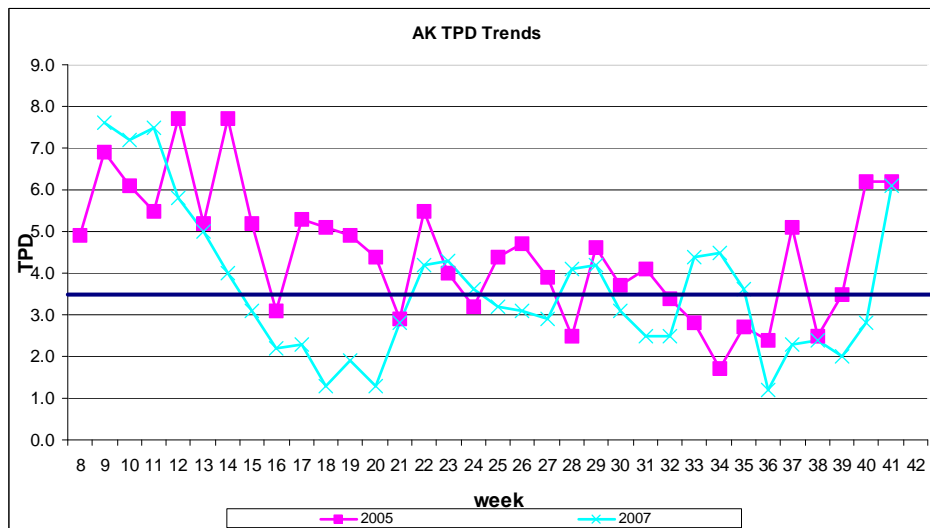
- *Lower boiling temperatures in the C-masseccuite pan.* Prior to 2006 high masseccuite temperatures were a problem, especially during summer, when the injection water temperatures would often reach 36°C and initiate Maillard-type reactions in the C-masseccuite. Repositioning of the feed ring and separation of the pipe vents for heavy and light incondensable gases resulted in a lower average masseccuite temperature of 64°C, as opposed to an average of 67°C before the modifications.
- *Improved TPD.* Improved pan circulation contributed to improved molasses exhaustion. Ninela and Rajoo (2006) highlighted improved Target Purity Difference (TPD) figures as a result of boiling at lower temperatures in 2005. A further improvement in TPD was achieved in 2007 (Figure 9). At the time of reporting, the 2007 figure was 3.6, whereas in 2005 it was 4.5.

**Figure 9. Comparison of target purity difference (TPD) trends at Amatikulu mill in 2005 and 2007.**

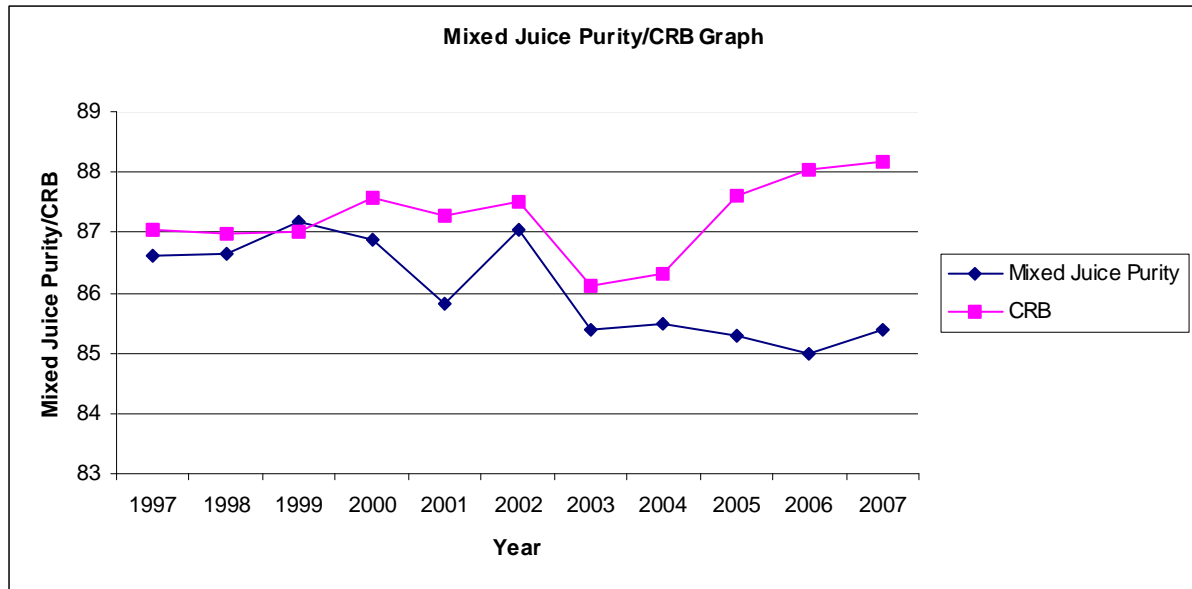
- *Improved CRB.* Corrected Reduced Boiling House Recovery (CRB) essentially determines how efficiently sugar is recovered and molasses is exhausted. It is independent of juice quality and reflects only those factors that are within the control of factory process management (Lionnet and Koster, 1987). The improvement in CRB since 2006, with a record 88% in 2007, is an indication of the improved molasses exhaustion achieved in 2006 and 2007 as a result of modifications to the incondensable gas pipes and the pan feed system, and of enhanced condensate removal in the C-massecuite pan (Figure 10).

**Figure 10. Mixed juice purity and corrected reduced boiling house recovery (CRB) at Amatikulu from 1997 to 2007.**
